Errata disclaimer: This Errata applies to SLG46621 revision PB.

## ISSUE: Long Settling Time for Ring OSC Functional Blocks Affected: Ring OSC, Delay, Counter

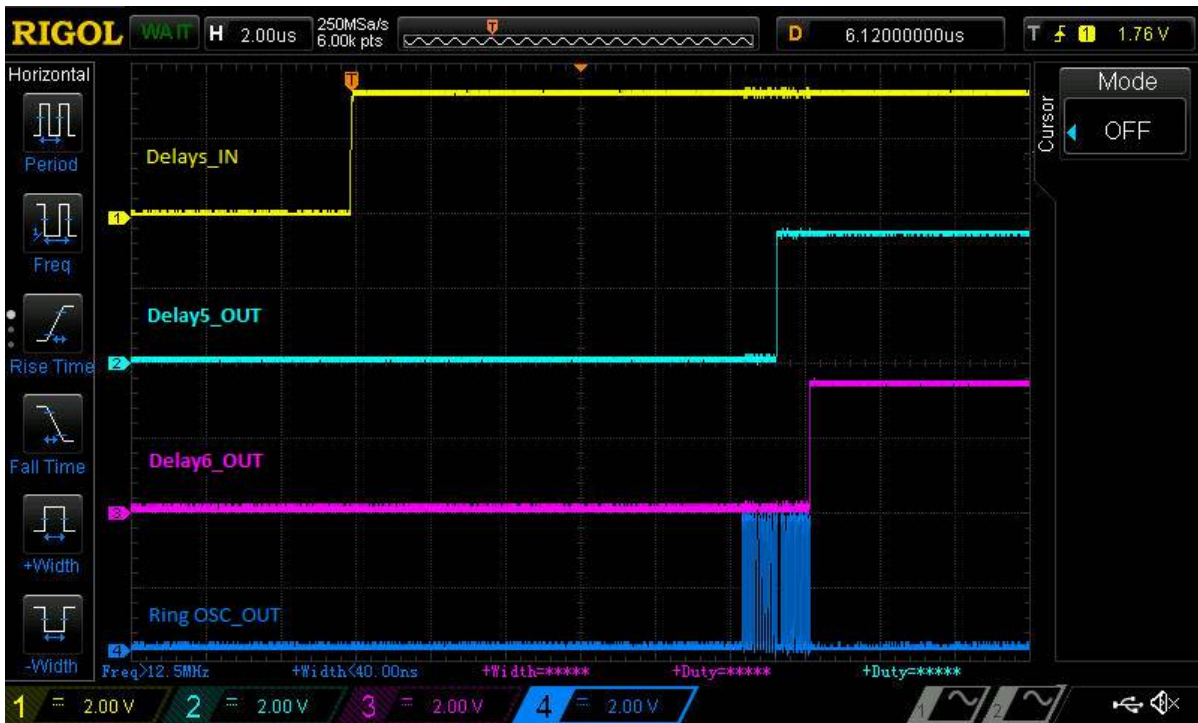
A similar situation can occur when using two connected delays (all edge detect types except when pairing “Rising edge DLY – Falling edge DLY”).

In the following example, Delay0 and Delay1 are configured in the same way. However, Delay0 time is 11.4us instead of expected 0.4us (Delay0 time).

- Set Ring OSC power mode to “Force Power On”
- Set Turn on by register option in BG (Band Gap) block as “Enable”

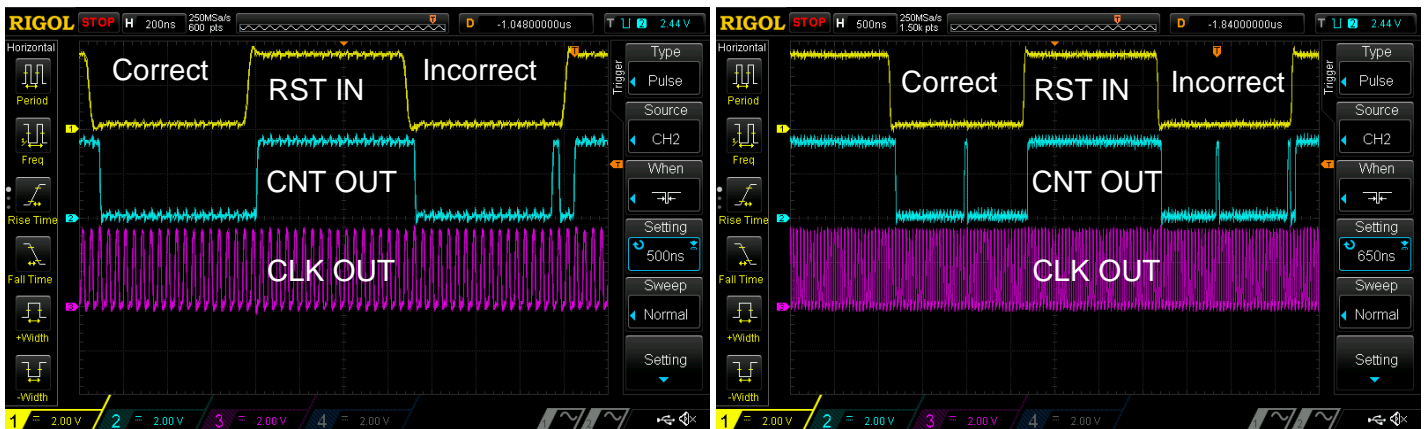
If the Counter Reset occurs at a time very close to a rising edge of the clock signal during clock signal generation (for example OSC operation), there is a possibility that the Counter Data of the Counter is reset incorrectly and the counter end signal (HIGH pulse) may appear faster than expected. This phenomena appears more frequently the higher the clock frequency is.

- Synchronize the RESET input of the Counter with its CLK using 2 DFF cells as shown in the image below.

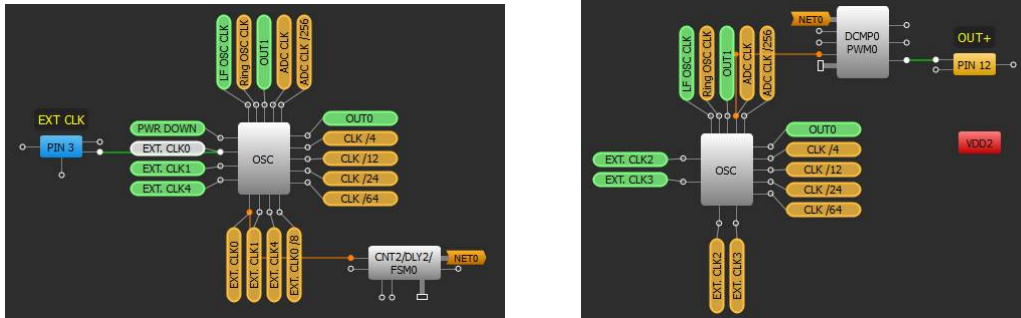
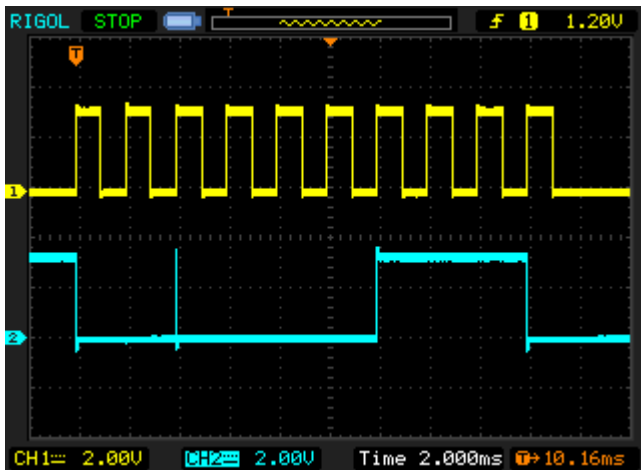
DCMP's OUT+ output may have a glitch when the input data is changed. This issue appears more frequently the higher DCMP clock is.

For example, DCMP IN+ sources from FSM0 and IN- from Register0. DCMP is clocked from the Ring OSC.

- Synchronize the data source clock with the DCMP clock source using 2 DFF cells as shown in the images below.

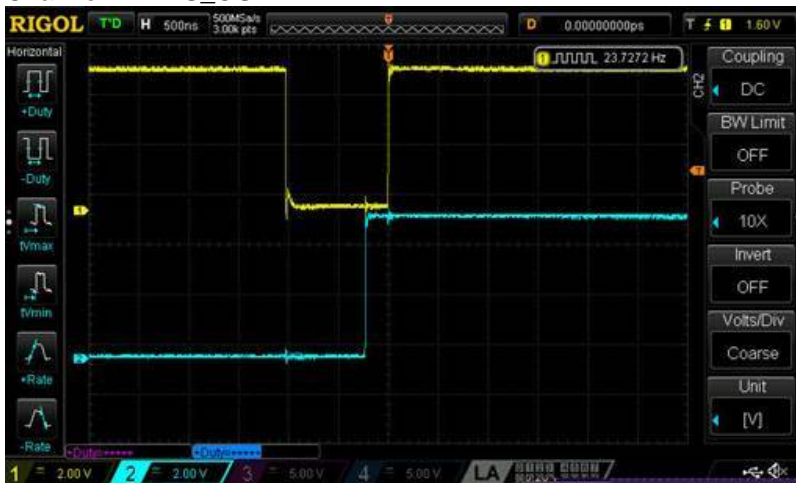
Channel 1 – ACMP out

The output of the ACMP incorrectly goes low even when IN+ is greater than IN- if the RING OSC is active when the WS signal rises

- Avoid using the RING OSC with the WS Controller, or add a filtering block on the ACMP output to filter out the glitch.
