Errata disclaimer: This Errata applies to SLG46621 revision PB.

ISSUE 1: Long Settling Time for Ring OSC Functional Blocks Affected: Ring OSC, Delay, Counter

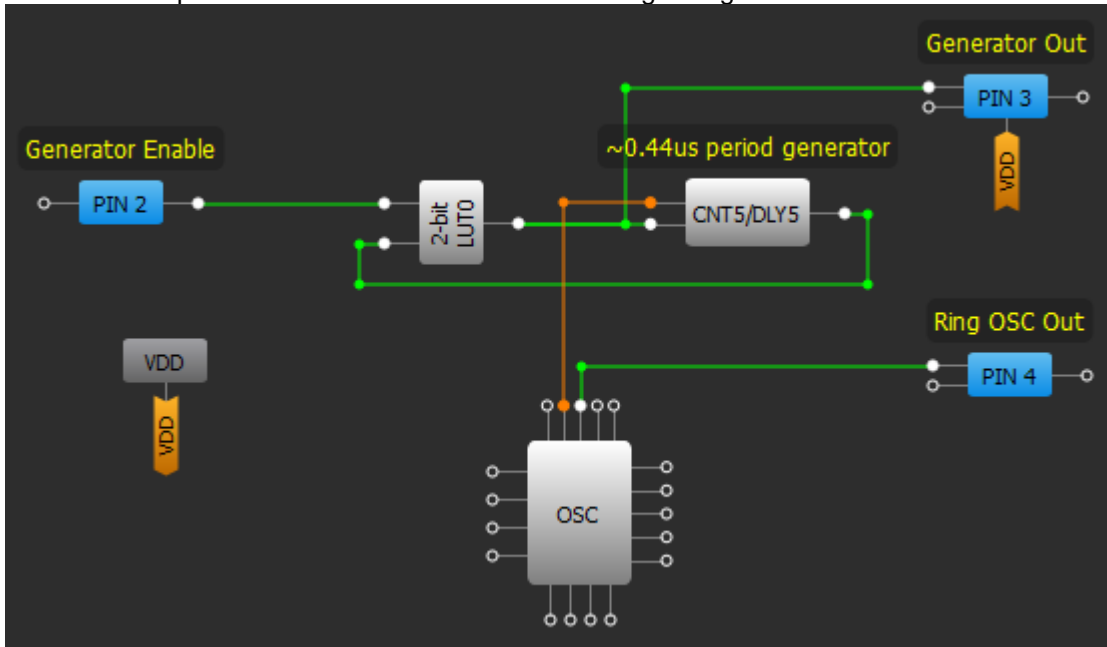
The Ring OSC has a longer settling time when configured as Auto Power On in the designs that have a very short Ring OSC disable time. An example of this issue is shown in the following configuration:

The configuration shown above generates a periodical signal with a frequency defined by the Delay cell and started by a high signal on PIN2. The issue becomes apparent in a longer settling time when the scheme generates short pulses (Delay is configured as a rising edge delay only). See waveform below.

- Set Ring OSC power mode to “Force Power On”
- Set Turn on by register option in BG (Band Gap) block as “Enable”

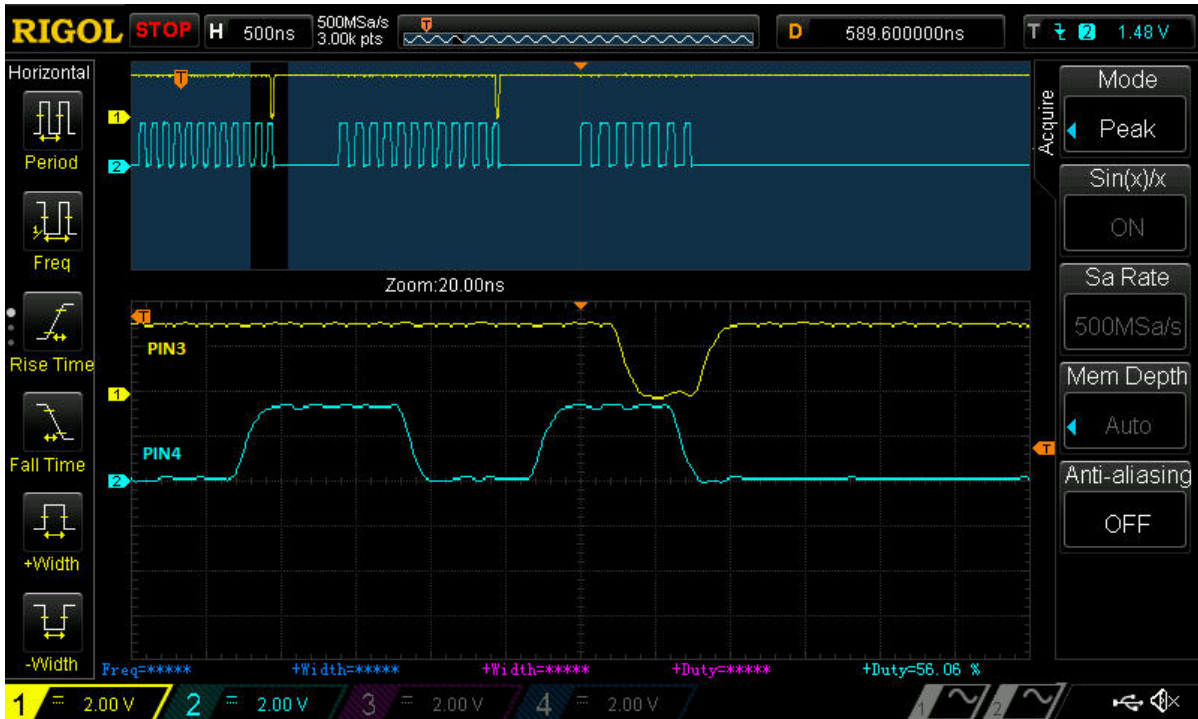
Channel 1 – 2-bit LUT0 output; Channel 2 – Ring OSC output

Such behavior will lead to substantial error in period calculations if the delay time is relatively small.

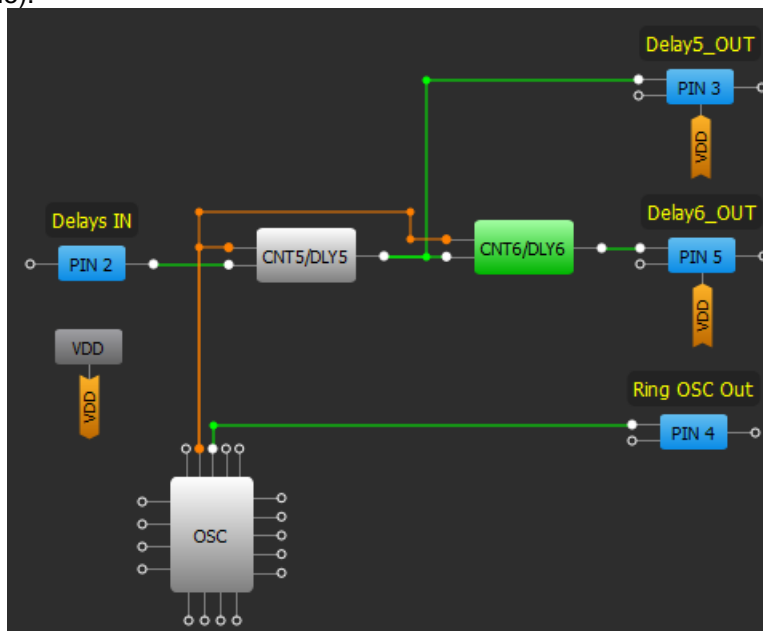
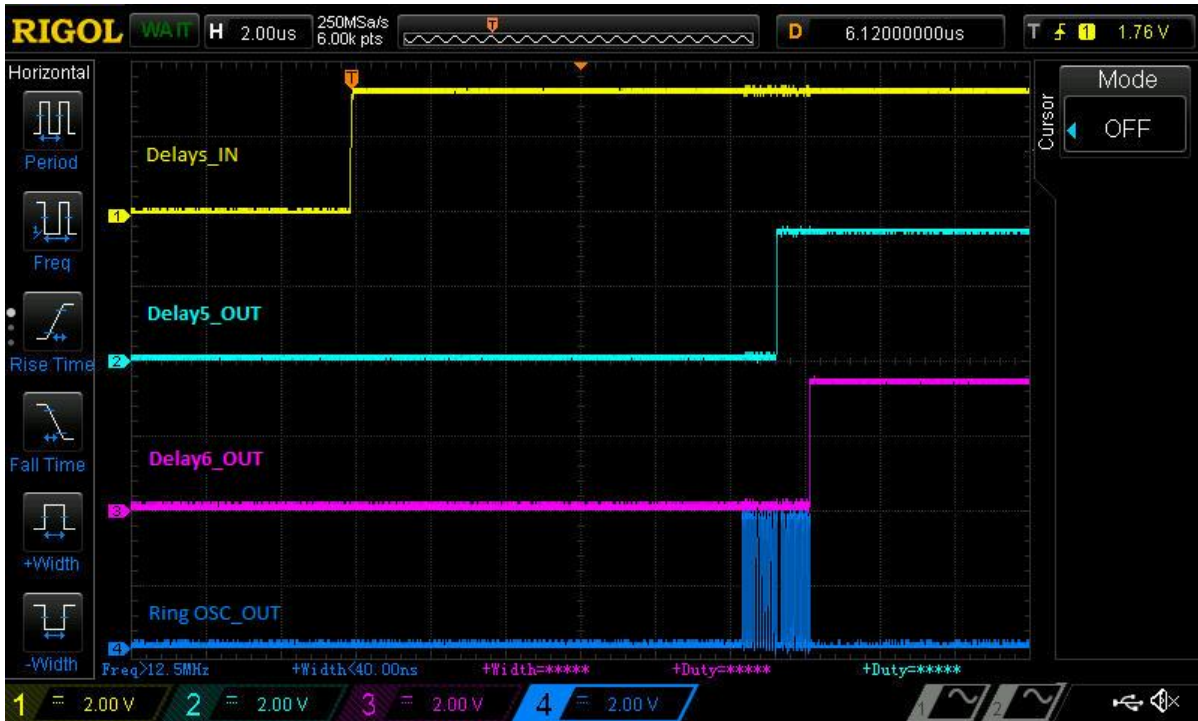
A similar situation can occur when using two connected delays (all edge detect types except when pairing “Rising edge DLY – Falling edge DLY”).

In the following example, Delay0 and Delay1 are configured in the same way. However, Delay0 time is 11.4us instead of expected 0.4us (Delay0 time).

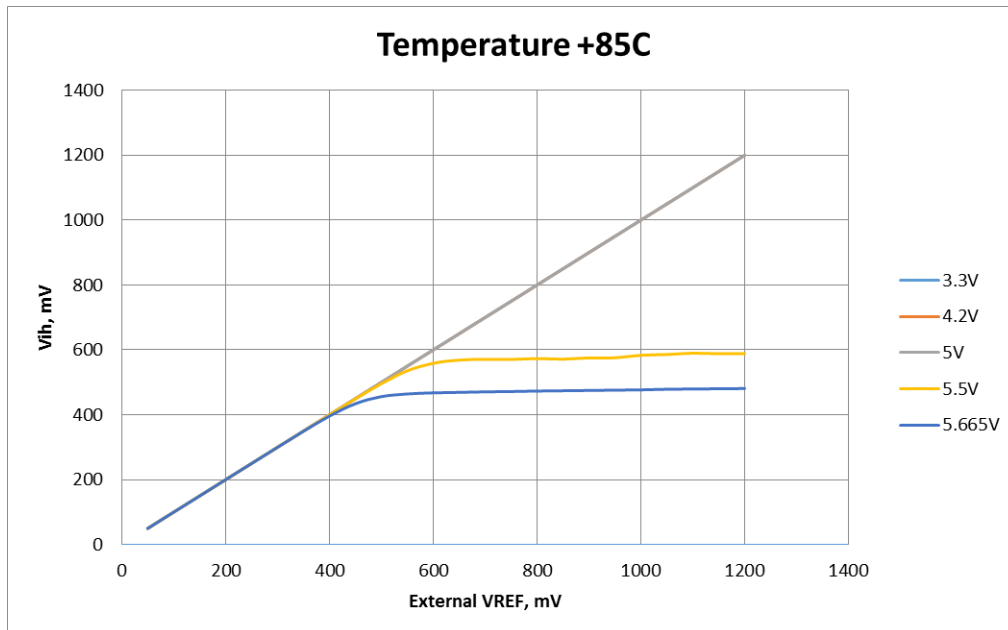
When using an external Vref source, the ACMP comparison may happen at the wrong threshold if the external Vref voltage is higher than a particular value (please see figure below) at high VDD values (> 5V) and high temperature.

- Avoid using ACMPs in such conditions.

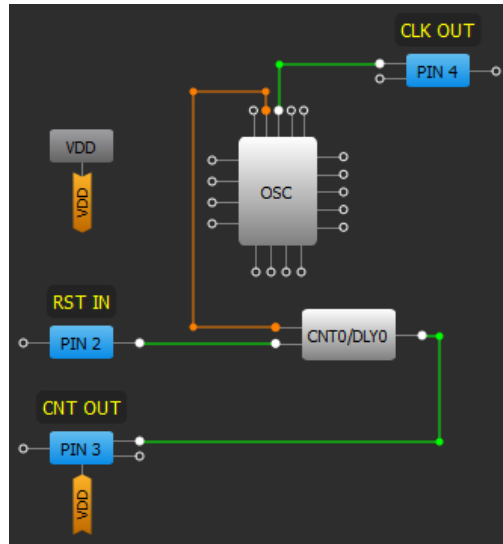
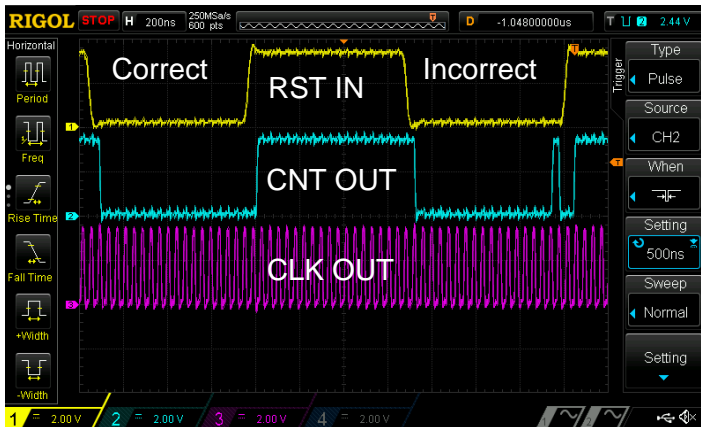
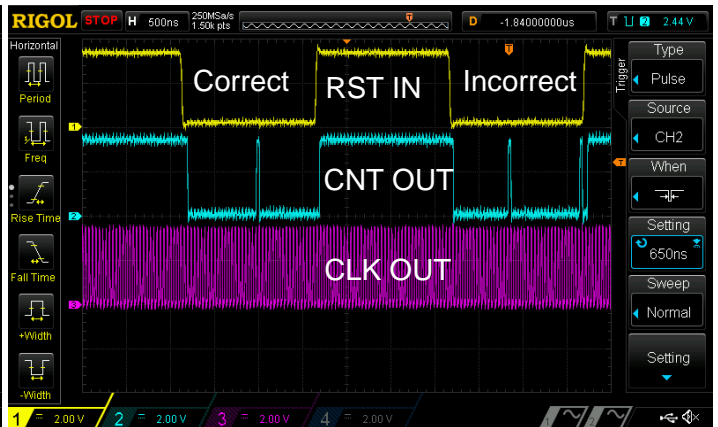
If the Counter Reset occurs at a time very close to a rising edge of the clock signal during clock signal generation (for example OSC operation), there is a possibility that the Counter Data of the Counter is reset incorrectly and the counter end signal (HIGH pulse) may appear faster than expected. This phenomena appears more frequently the higher the clock frequency is.

- Synchronize the RESET input of the Counter with its CLK using 2 DFF cells as shown in the image below.

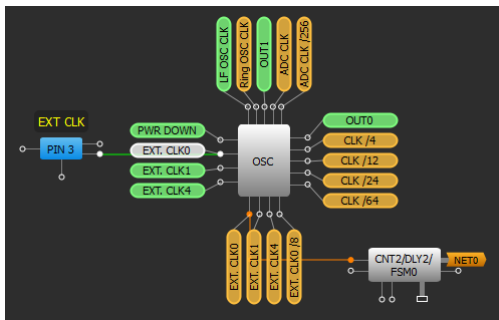
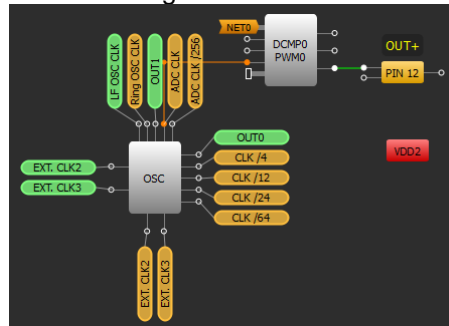
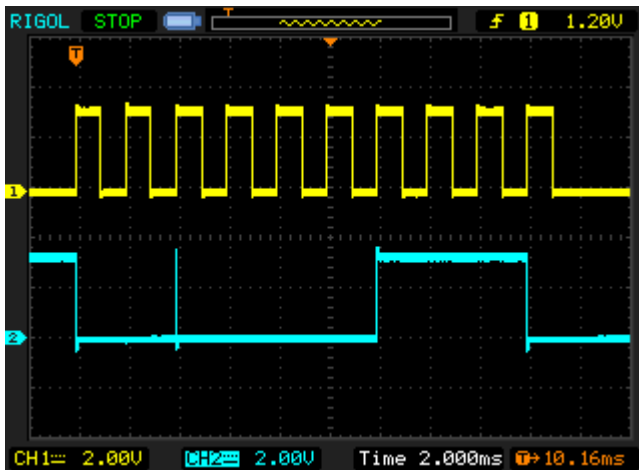
DCMP's OUT+ output may have a glitch when the input data is changed. This issue appears more frequently the higher DCMP clock is.

For example, DCMP IN+ sources from FSM0 and IN- from Register0. DCMP is clocked from the Ring OSC.

- Synchronize the data source clock with the DCMP clock source using 2 DFF cells as shown in the images below.

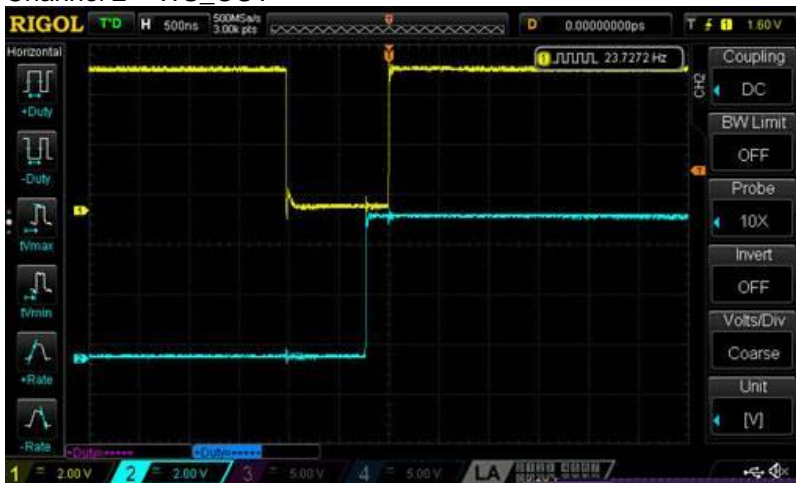
The output of the ACMP incorrectly goes low even when IN+ is greater than IN- if the RING OSC is active when the WS signal rises

Channel 1 – ACMP out

Channel 2 – WS_OUT

- Avoid using the RING OSC with the WS Controller, or add a filtering block on the ACMP output to filter out the glitch.
