Errata disclaimer: This Errata applies to SLG46140 revision LS.

## ISSUE: Long Settling Time for Ring OSC Functional Blocks Affected: Ring OSC, Delay, Counter

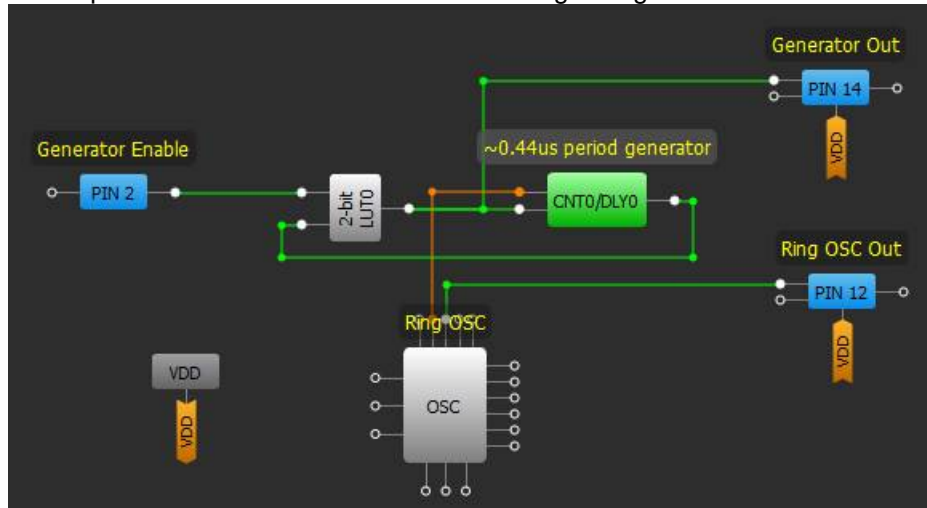
The Ring OSC has a longer settling time when configured as Auto Power On in the designs that have a very short Ring OSC disable time. An example of this issue is shown in the following configuration:

- Set Ring OSC power mode to “Force Power On”
- Set Turn on by register option in BG (Band Gap) block to “Enable”

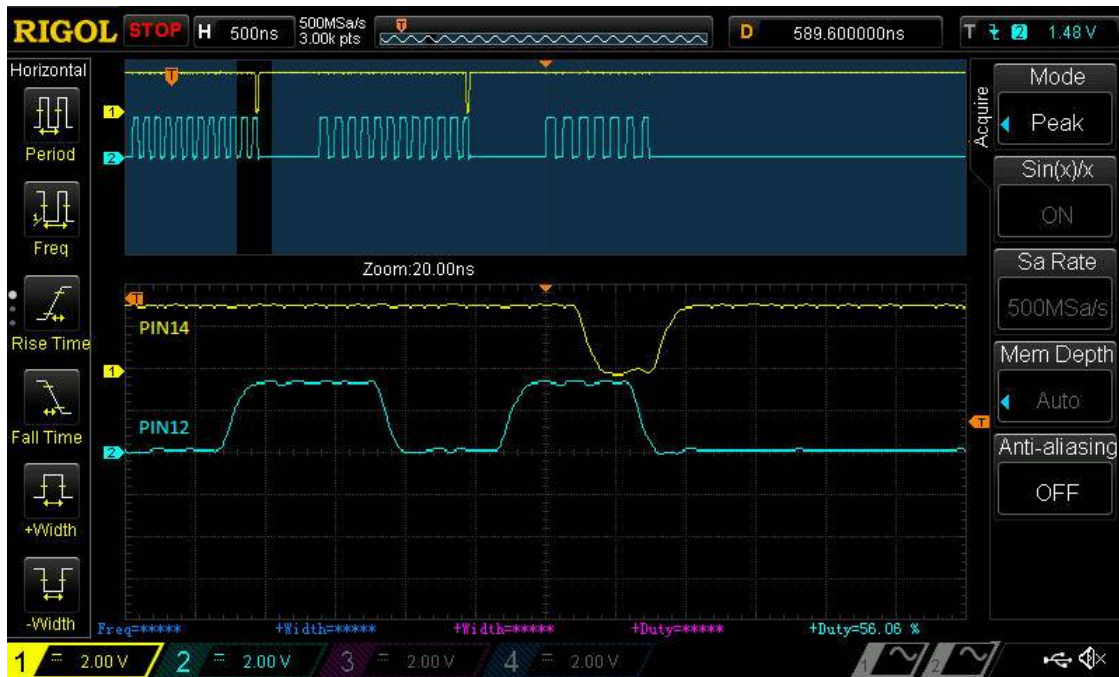
The configuration shown above generates a periodic signal with a frequency defined by the Delay cell and started by a high signal on PIN2. The issue of a longer settling time becomes apparent when the scheme generates short pulses (Delay is configured as a rising edge delay only). See waveform below.

Channel 1 – 2-bit LUT0 output; Channel 2 – Ring OSC output

Such behavior will lead to substantial error in period calculations if the delay time is relatively small.

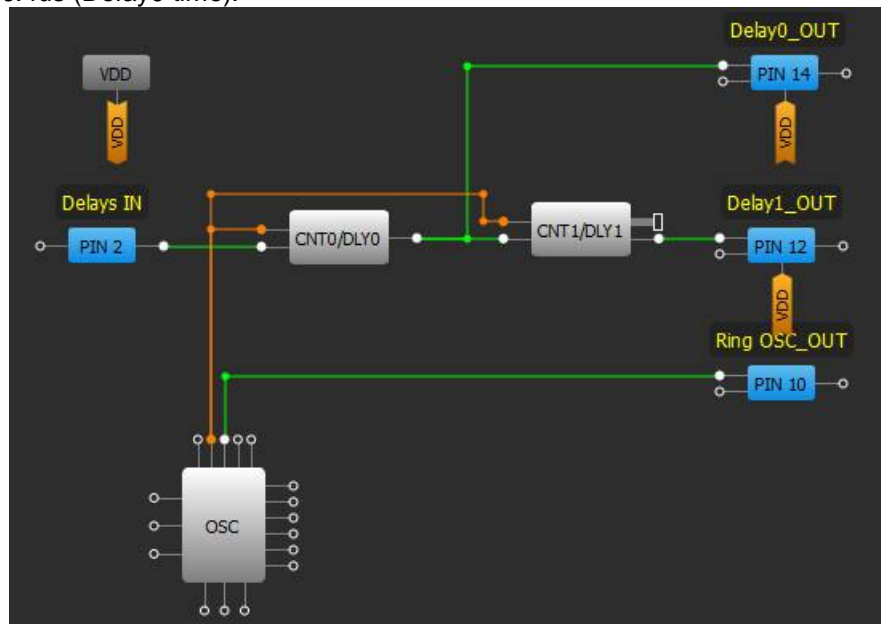
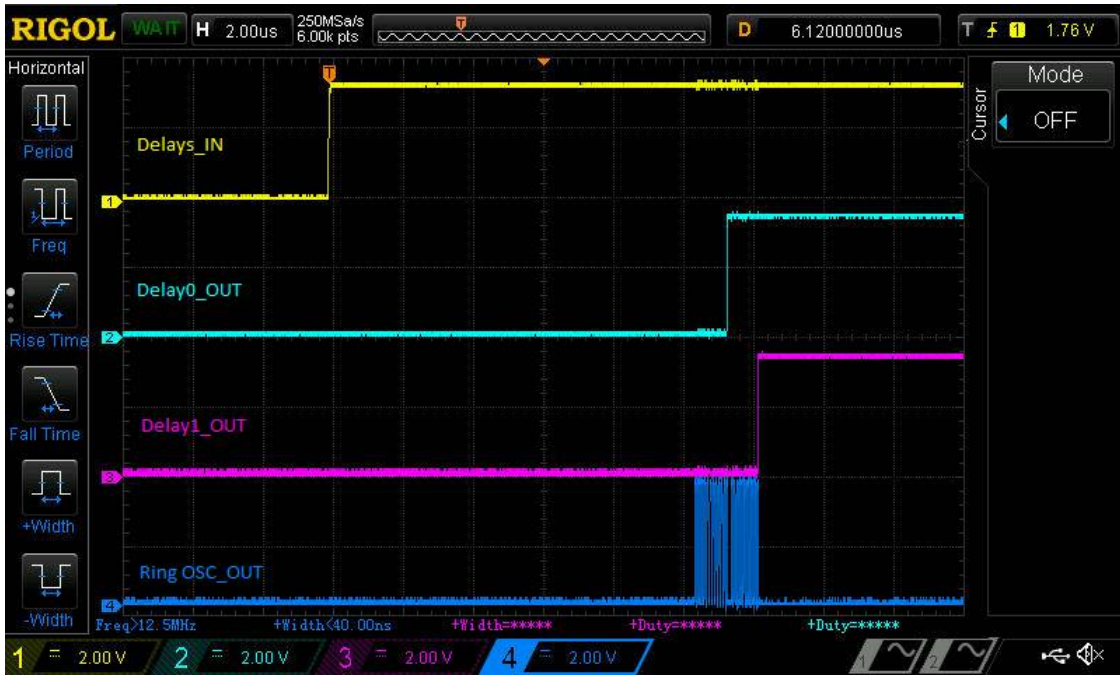
A similar situation can occur when using two connected delays (all edge detect types except when pairing “Rising edge DLY – Falling edge DLY”).

In the following example, Delay0 and Delay1 are configured in the same way. However, Delay0 time is 11.4us instead of the expected value of 0.4us (Delay0 time).

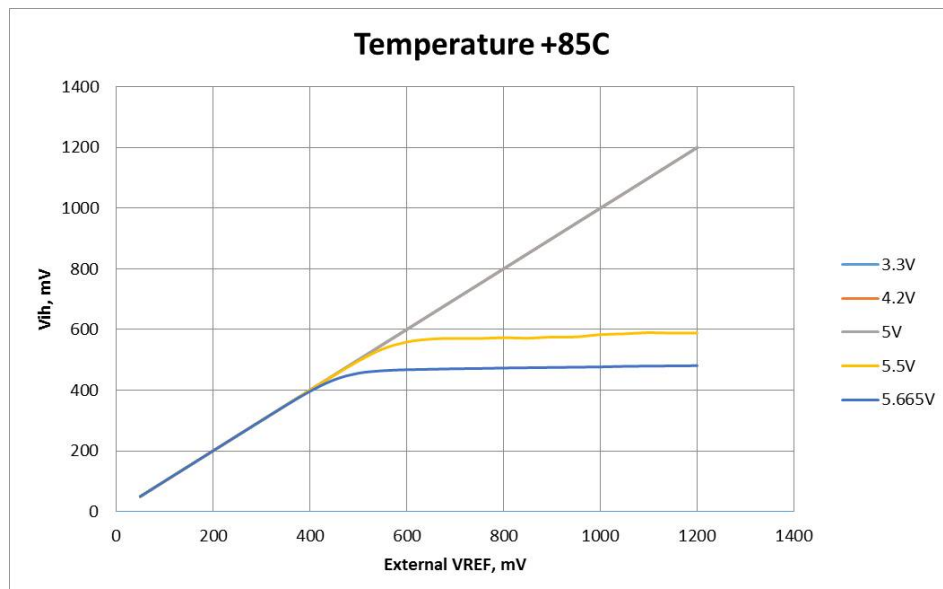
When using an external Vref source, the ACMP comparison may happen at the wrong threshold if the external Vref voltage is higher than a particular value (please see figure below) at high VDD values (> 5V) and high temperature.

- Avoid using ACMPs in such conditions.

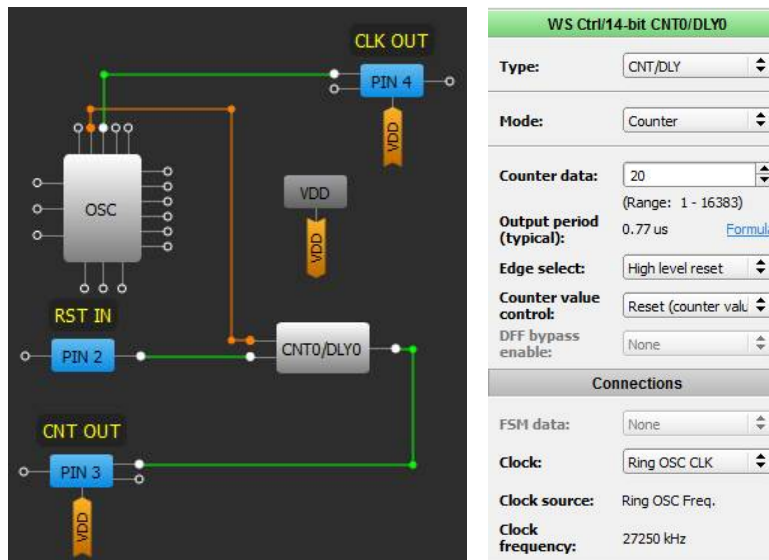
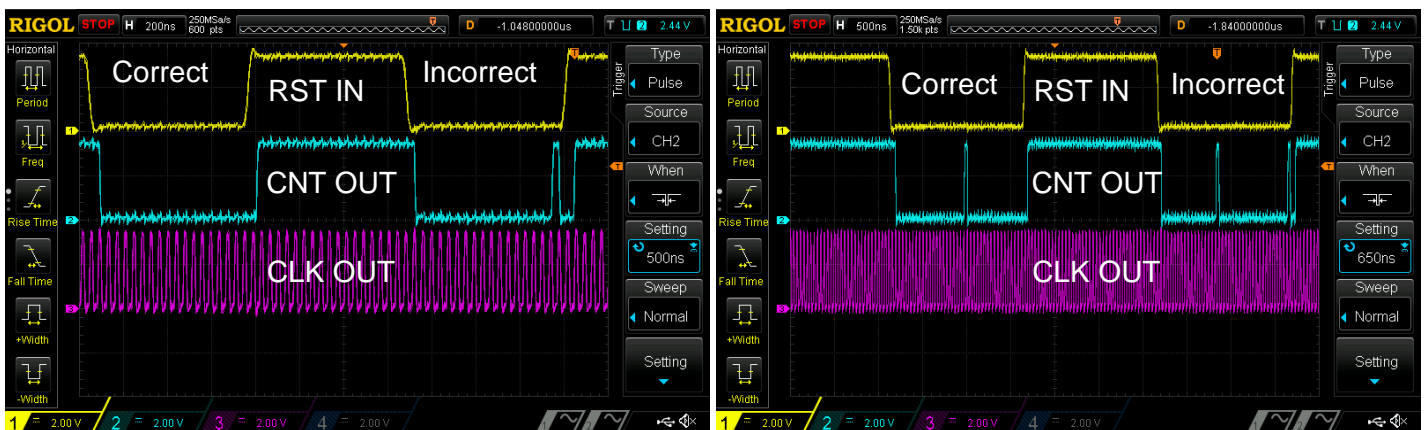
If the Counter Reset occurs at a time very close to a rising edge of the clock signal during clock signal generation (for example OSC operation), there is a possibility that the Counter Data of the Counter is reset incorrectly and the counter end signal (HIGH pulse) may appear faster than expected. This phenomena appears more frequently the higher the clock frequency is.

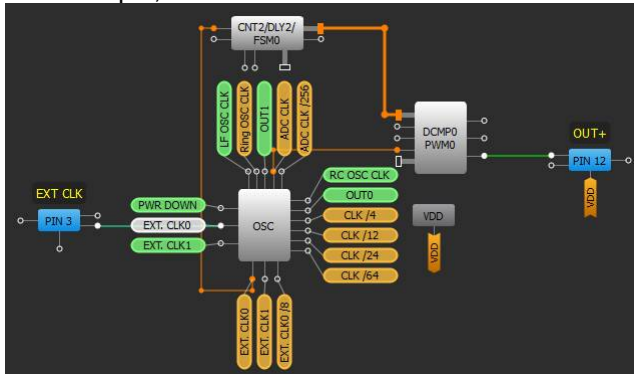
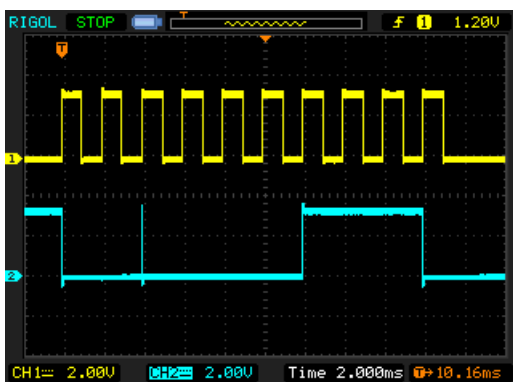
DCMP's OUT+ output may have a glitch when the input data is changed. This issue appears more frequently the higher the DCMP clock is.

For example, DCMP IN+ sources from FSM0 and IN- from Register0. DCMP is clocked from the Ring OSC.

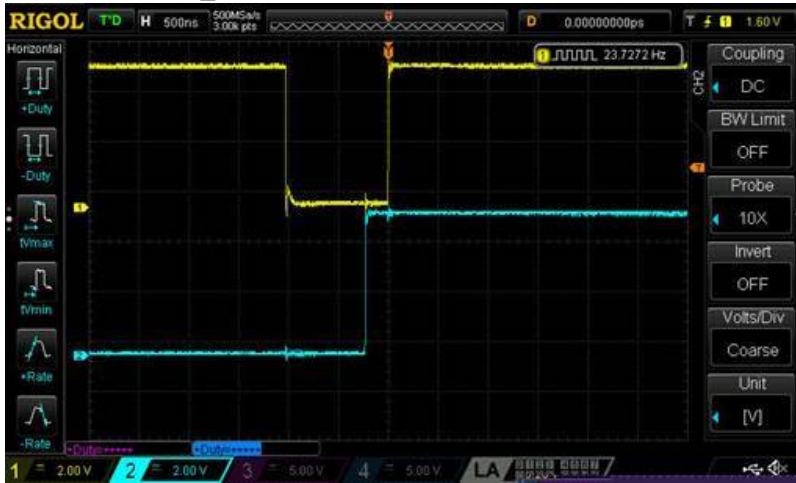
The output of the ACMP incorrectly goes low even when IN+ is greater than IN- if the RING OSC is active when the WS signal rises

Channel 1 – ACMP out  
Channel 2 – WS\_OUT

- Avoid using the RING OSC with the WS Controller, or add a filtering block on the ACMP output to filter out the glitch.
