Errata disclaimer: This Errata applies to SLG46620B revision PA.

## ISSUE: Long Settling Time for Ring OSC

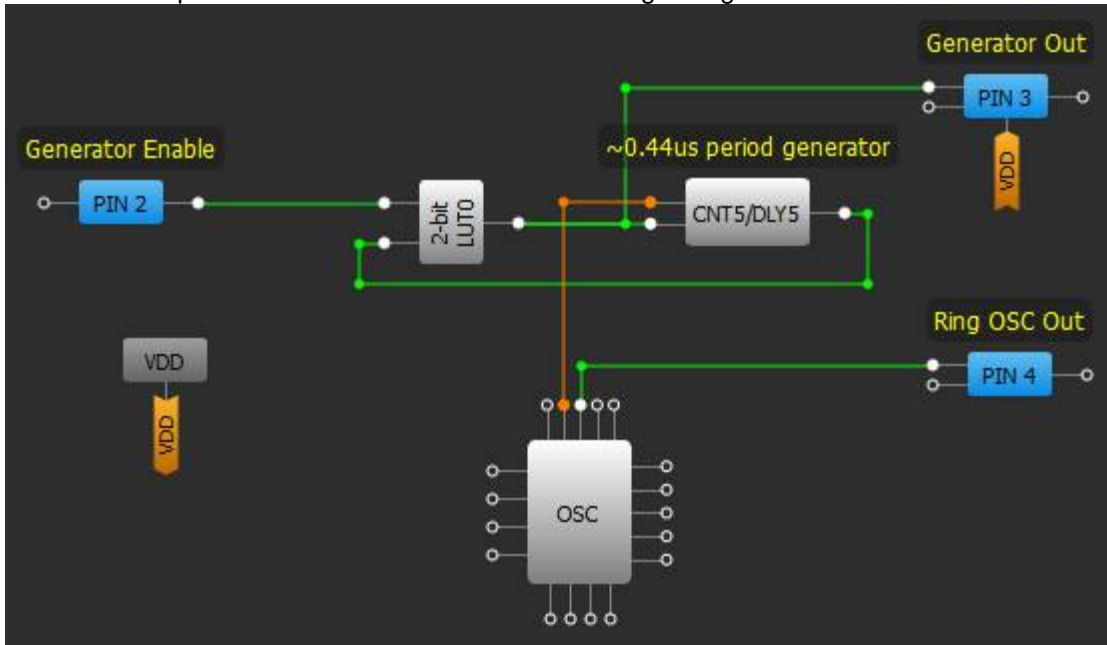
The Ring OSC has a longer settling time when configured as Auto Power On in the designs that have a very short Ring OSC disable time. An example of this issue is shown in the following configuration:

The configuration shown above generates a periodical signal with a frequency defined by the Delay cell and started by a high signal on PIN2. The issue becomes apparent in a longer settling time when the scheme generates short pulses (Delay is configured as a rising edge delay only). See waveform below.

Workaround:

- Set Ring OSC power mode to “Force Power On”
- Set Turn on by register option in BG (Band Gap) block as “Enable”

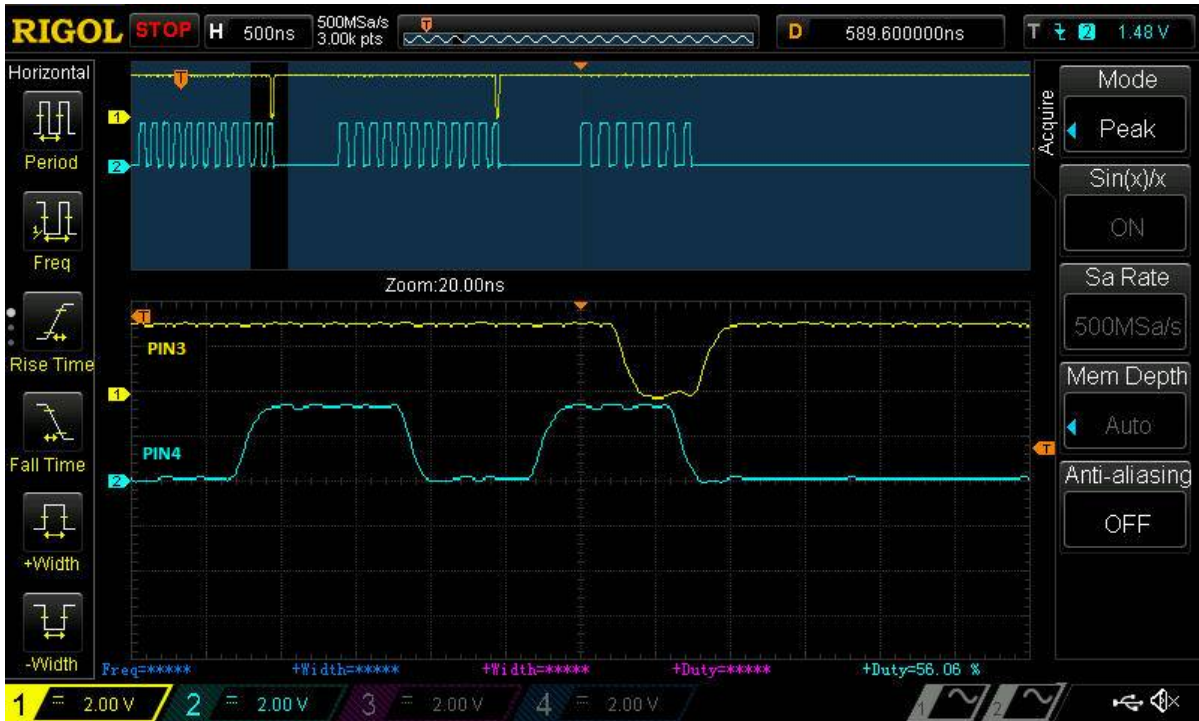
Channel 1 – 2-bit LUT0 output; Channel 2 – Ring OSC output

Such behavior will lead to substantial error in period calculations if the delay time is relatively small.

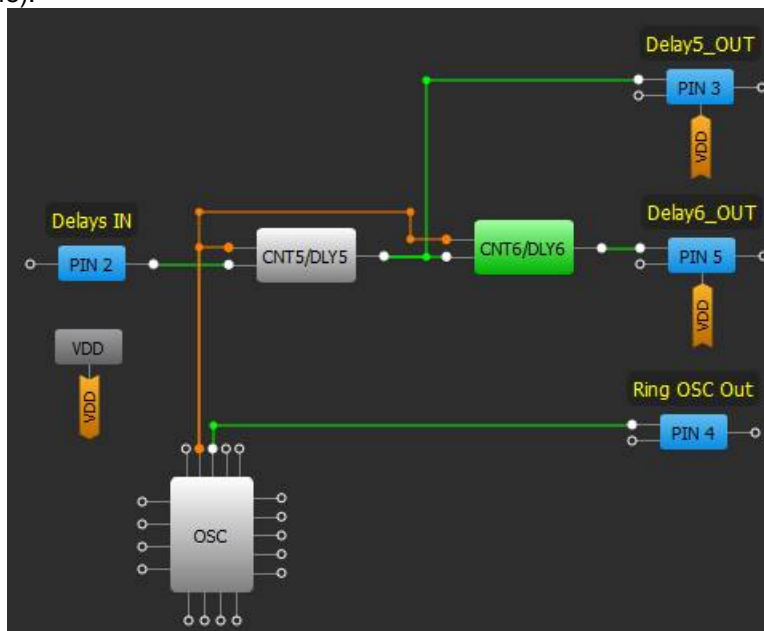
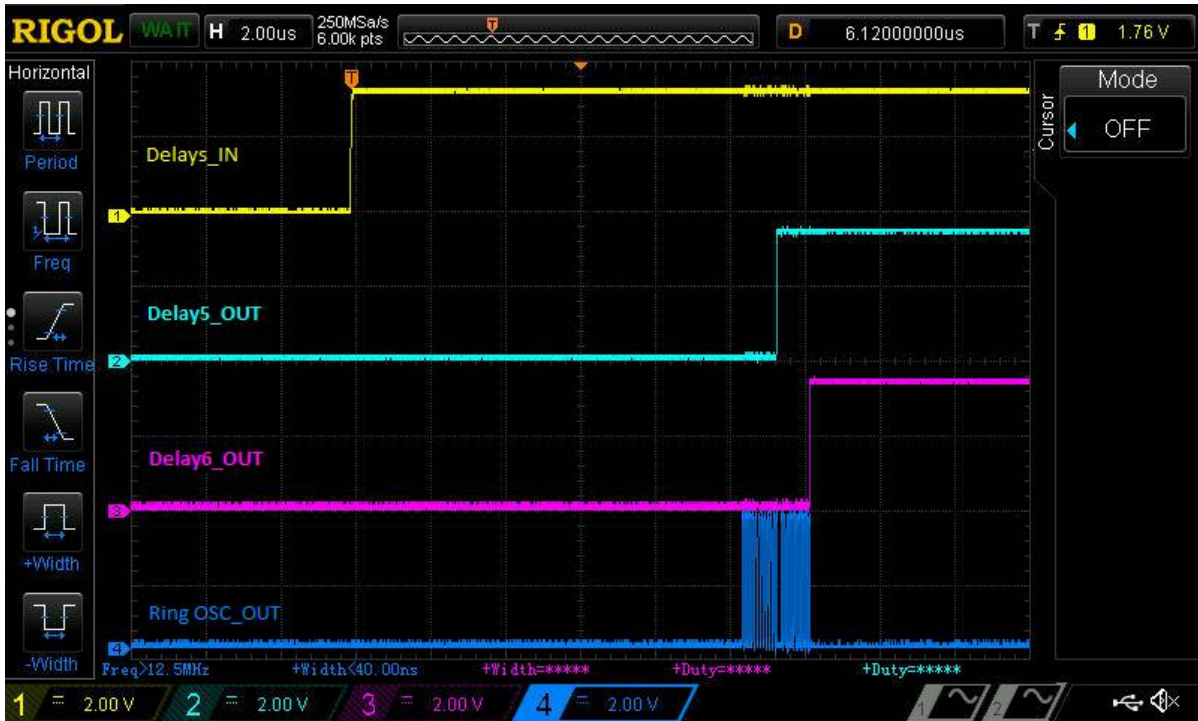
A similar situation can occur when using two connected delays (all edge detect types except when pairing “Rising edge DLY – Falling edge DLY”).

In the following example, Delay0 and Delay1 are configured in the same way. However, Delay0 time is 11.4us instead of expected 0.4us (Delay0 time).

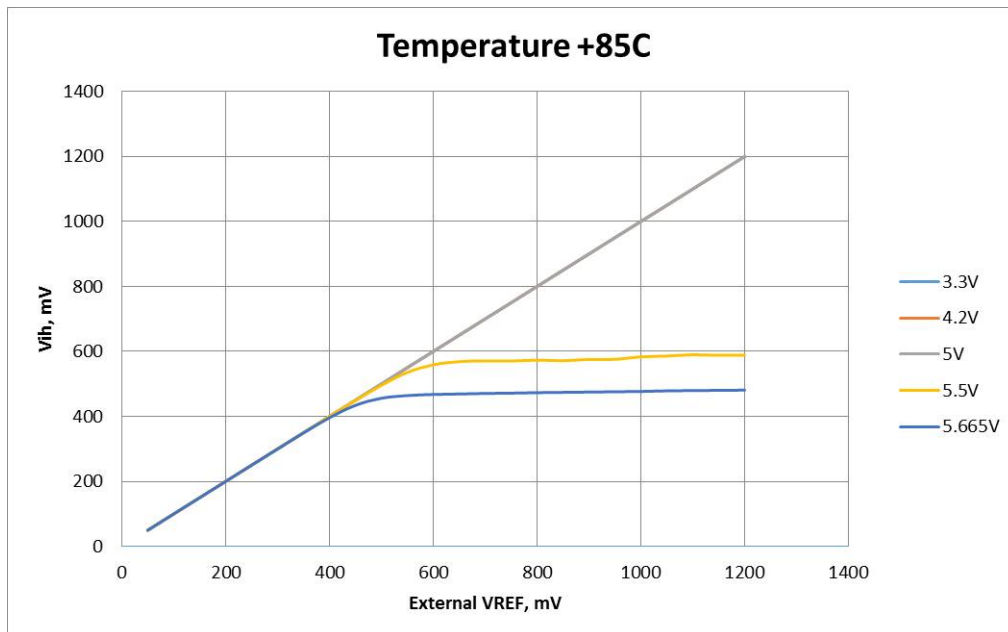
When using an external Vref source, the ACMP comparison may happen at the wrong threshold if the external Vref voltage is higher than a particular value (please see figure below) at high VDD values (> 5V) and high temperature.

- Avoid using ACMPs in such conditions.

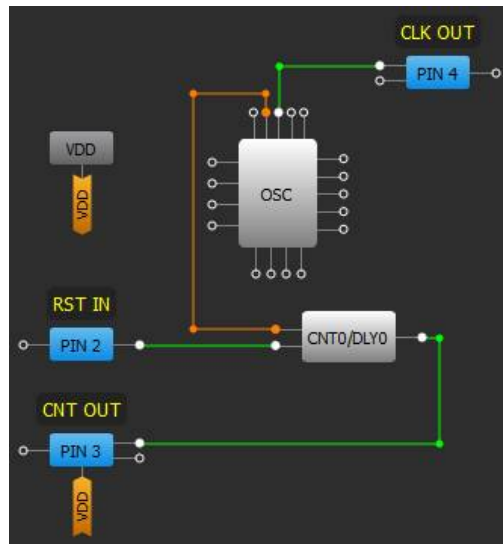
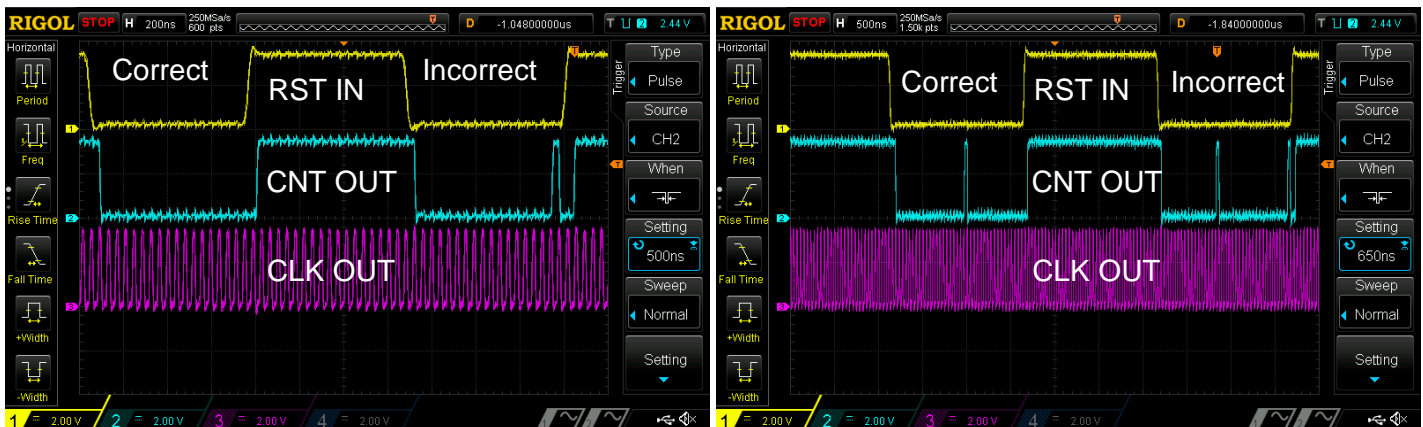
If the Counter Reset occurs at a time very close to a rising edge of the clock signal during clock signal generation (for example OSC operation), there is a possibility that the Counter Data of the Counter is reset incorrectly and the counter end signal (HIGH pulse) may appear faster than expected. This phenomena appears more frequently the higher the clock frequency is.

- Synchronize the RESET input of the Counter with its CLK using 2 DFF cells as shown in the image below.

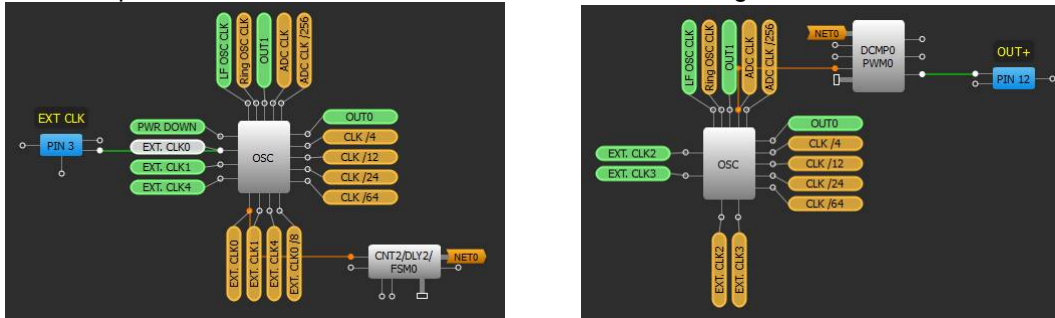
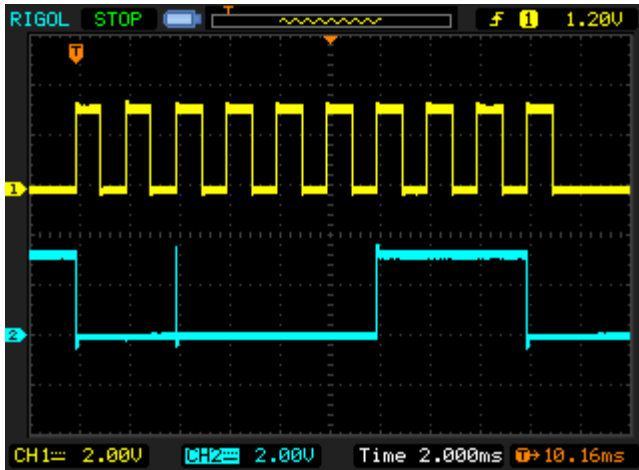
DCMP's OUT+ output may have a glitch when the input data is changed. This issue appears more frequently the higher DCMP clock is.

For example, DCMP IN+ sources from FSM0 and IN- from Register0. DCMP is clocked from the Ring OSC.

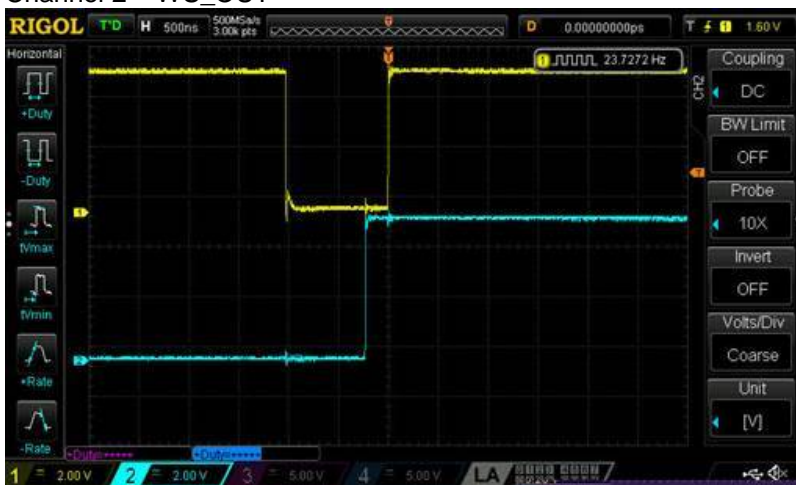
The output of the ACMP incorrectly goes low even when IN+ is greater than IN- if the RING OSC is active when the WS signal rises

Channel 1 – ACMP out

Channel 2 – WS\_OUT

- Avoid using the RING OSC with the WS Controller, or add a filtering block on the ACMP output to filter out the glitch.
