Errata disclaimer: This Errata applies to SLG46116 revision YA.

ISSUE 1: Long RC OSC Settling Time Functional Block Affected: RC OSC, Counter, Delay

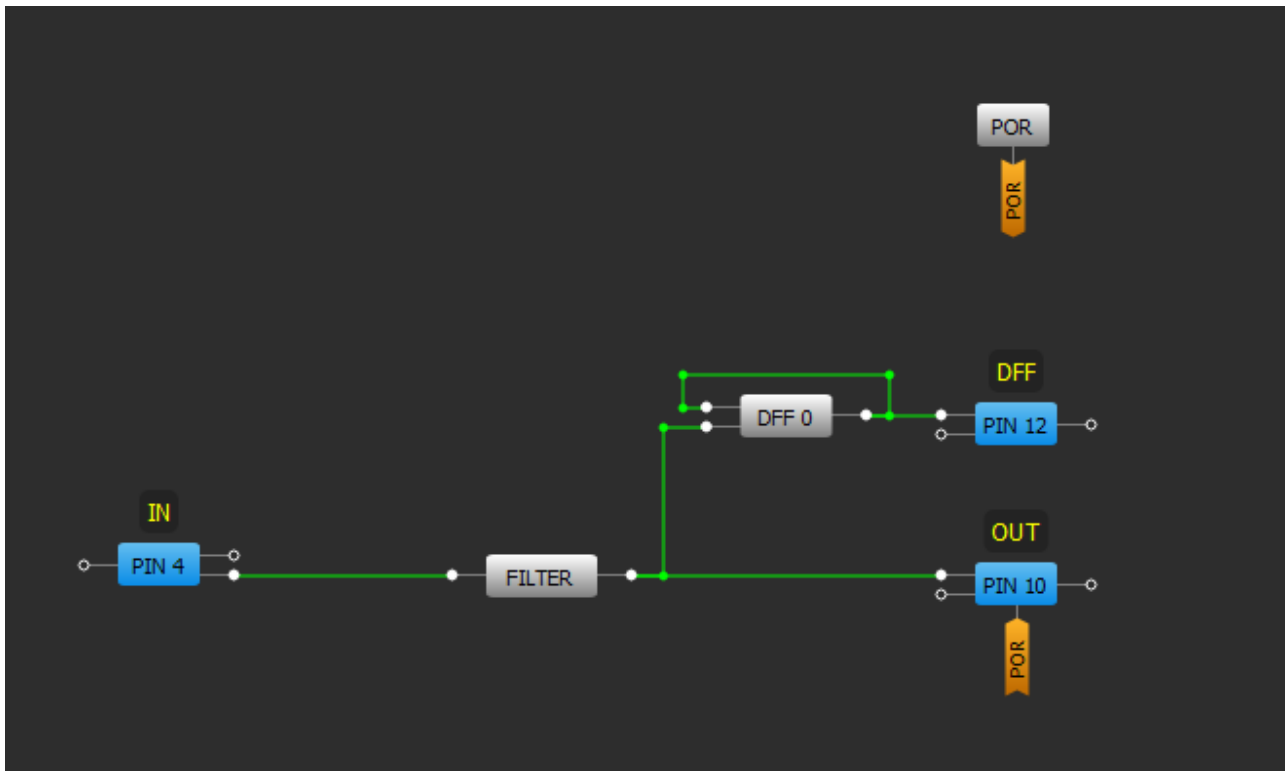
If clock type high frequency input comes in, the FILTER cell may not filter out it. There are several factors like input frequency, duty cycle and LOW duration in such signal that may lead to its passing through FILTER block.

Channel 1 (yellow/top line) – PIN#4 (IN)
Channel 2 (light blue/2nd line) – PIN#10 (OUT)
Channel 3 (magenta /3rd line) – PIN#12 (DFF)

Currently there is no workaround for this issue. Filter block is good at filtering short spontaneous glitches. It is intended to be used in series connection before the delay cell to avoid its latching (see issue #5).

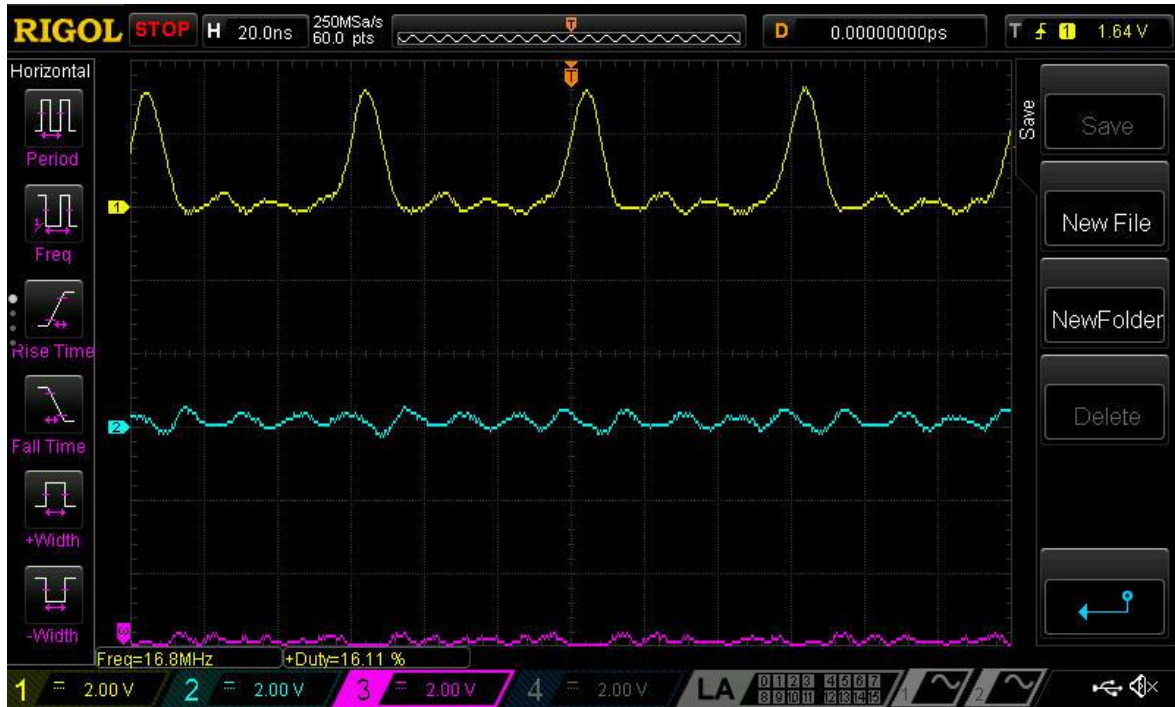
1. Period is 60ns. Pulse width is 10ns DC=16.7% (Correct functionality)

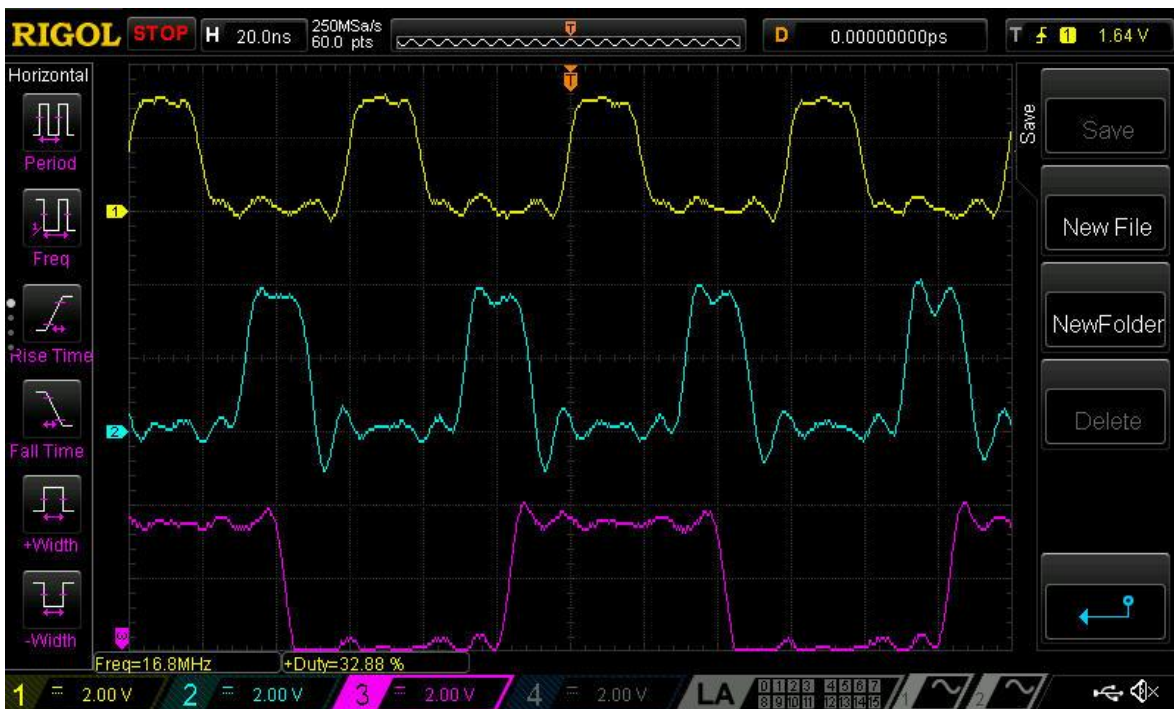
2. Period is 60ns. Pulse width is 20ns DC = 33.3% (Incorrect functionality)

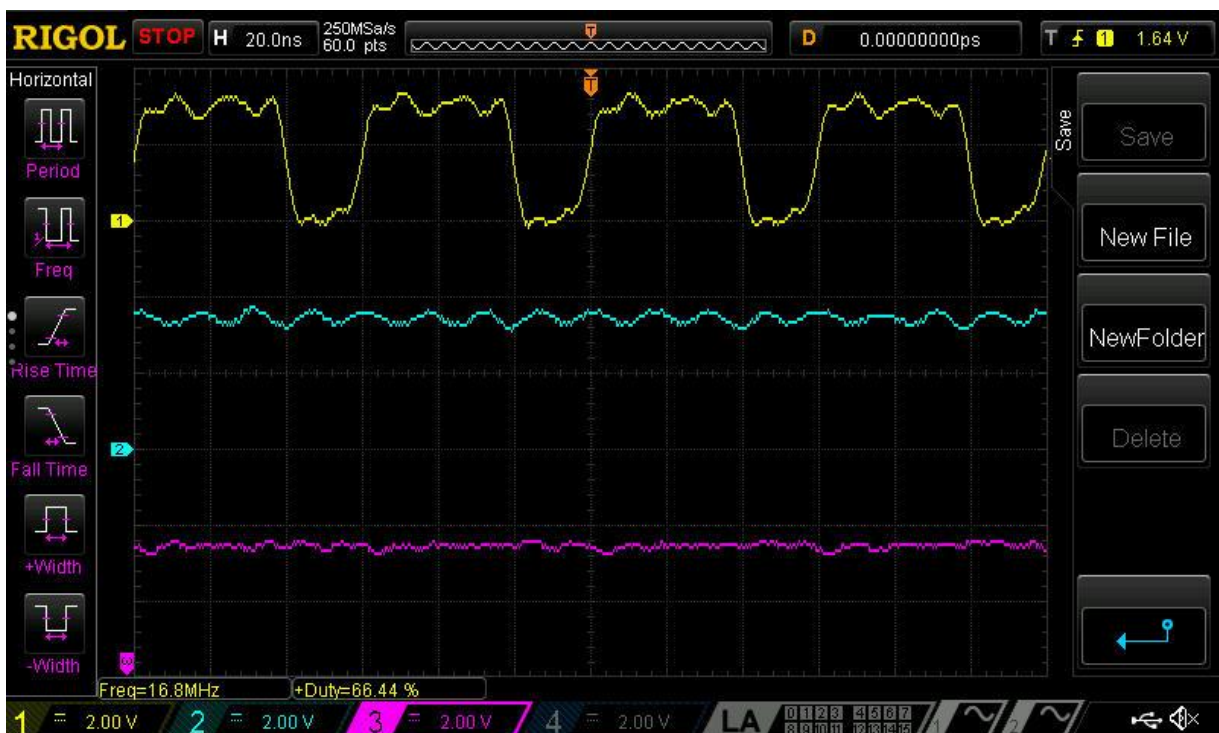
4. Period is 60ns. Pulse width is 40ns DC=66.67% (Correct functionality)
