Errata disclaimer: This Errata applies to SLG46117 revision YA.

ISSUE 1: Long RC OSC Settling Time Functional Block Affected: RC OSC, Counter, Delay

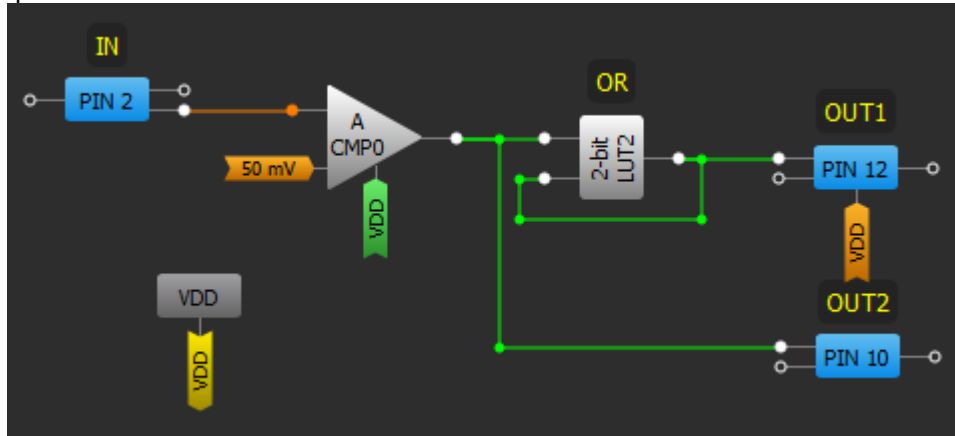
In some cases, ACMP may have short high-level glitches on its output (even if IN+ voltage is less than IN- voltage) after GreenPAK chip being powered up. Such cases may appear when using ACMP with Low Bandwidth mode enabled and Power Up is connected directly to the VDD.

In order to detect such glitches, scheme with additional LUT was used. This LUT detects high level on ACMP output and stays high until chip powers down.

- Use POR block, connected to the ACMP's Power Up pin. However, in this case ACMP will start working with low level output and will be able to go high only after POR goes high + ACMP power on time.

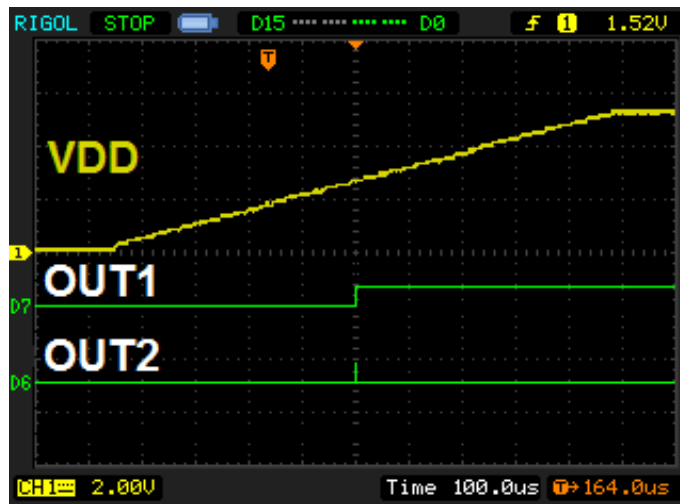
ACMP IN+ is connected to the Ground.
