Errata disclaimer: This Errata applies to SLG46117 revision YA.

## ISSUE 1: Long RC OSC Settling Time Functional Block Affected: RC OSC, Counter, Delay

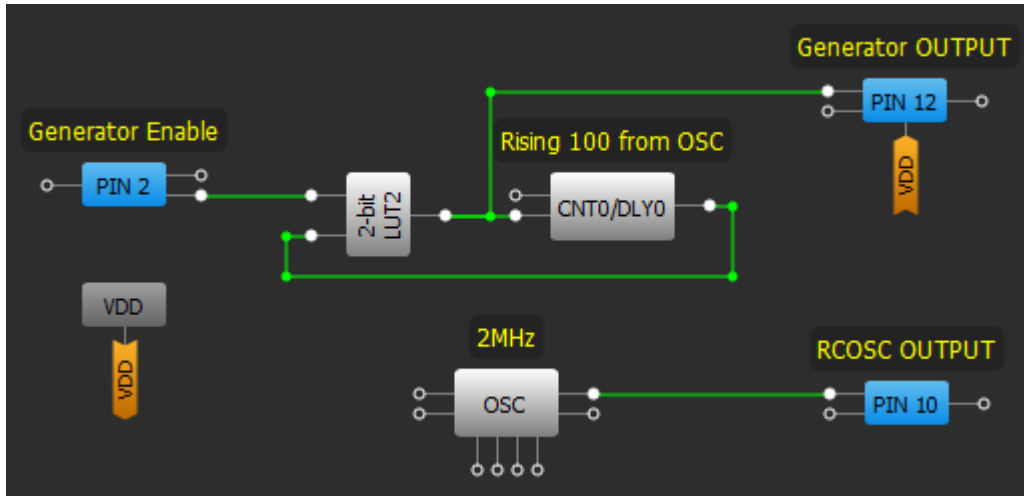
The RC OSC has a longer settling time when configured as 2 MHz with Auto Power On in the designs that have very short RC OSC disable time.

An example of such issue is in the following configuration:

The configuration shown above generates a periodical signal with a frequency defined by the Delay cell and started by a HIGH signal on PIN2. The issue becomes apparent in a longer settling time when the scheme generates short pulses (Delay is configured as a rising edge delay only). See waveform below.

- In first case use block with longer propagation time.

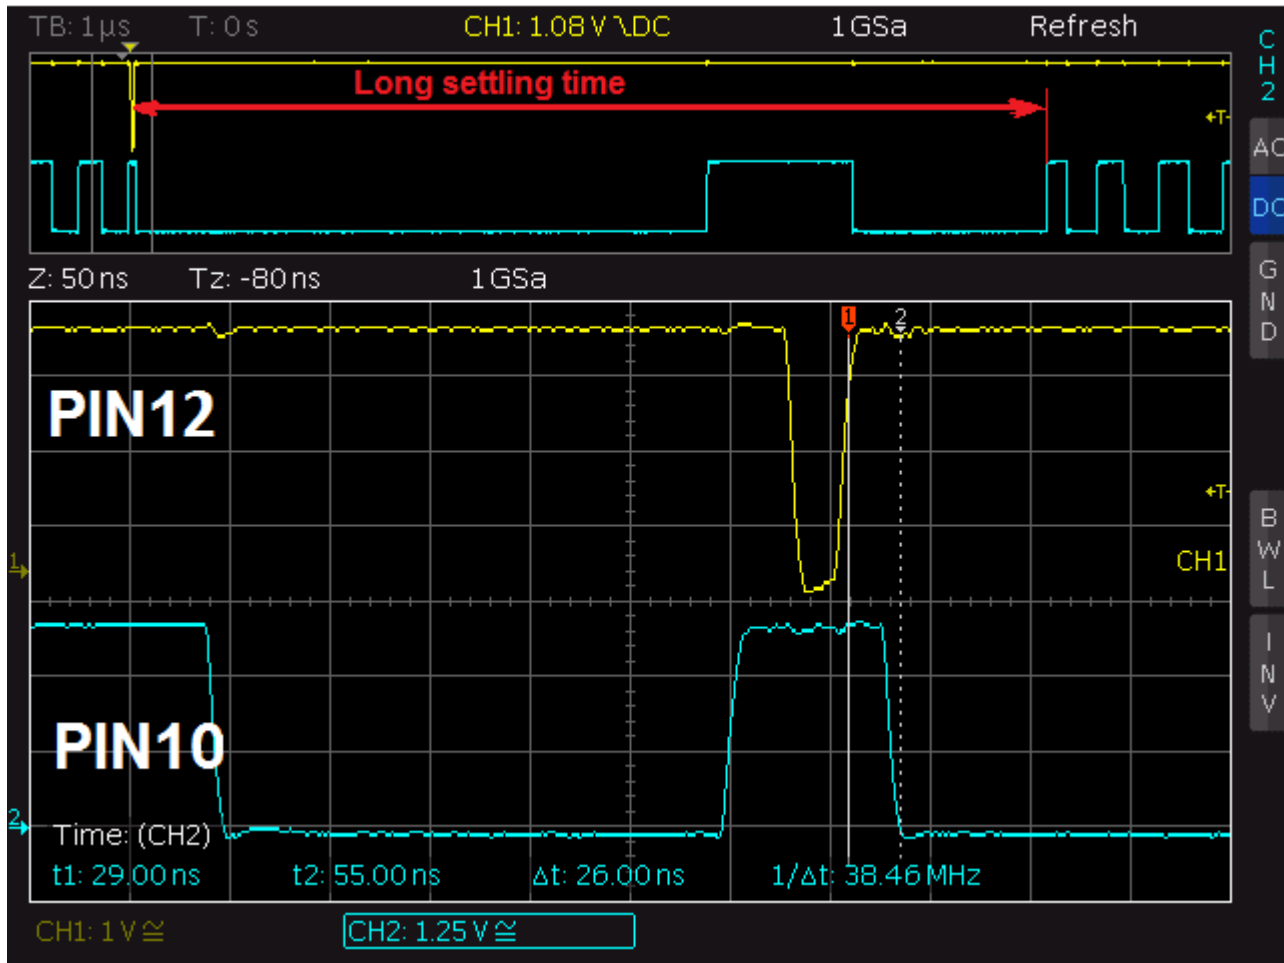
Such behavior will lead to substantial error in period calculations if the delay time is relatively small.

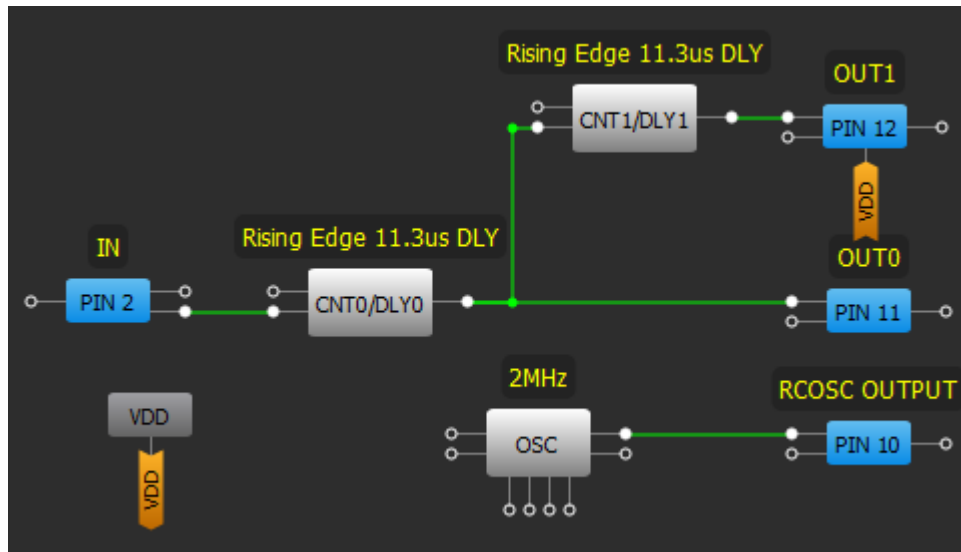
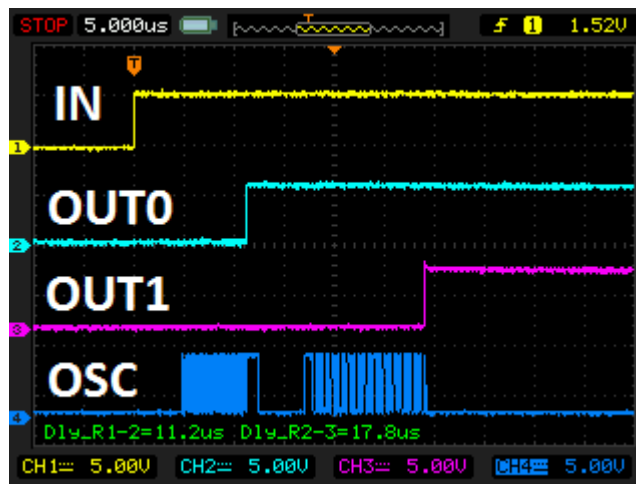
The same situation occur while using two connected delays (all edge detect types except for a pair “Rising edge DLY – Falling edge DLY”).

In the following example, Delay0 and Delay1 are configured in the same way. However, Delay1 time is 17.8us instead of expected 11.3us (Delay0 time).

- Using two delays in series (except for a pair “Rising edge DLY – Falling edge DLY”) use one Filter cell or P DLY between delay blocks. Using LUTs won’t help in this case.

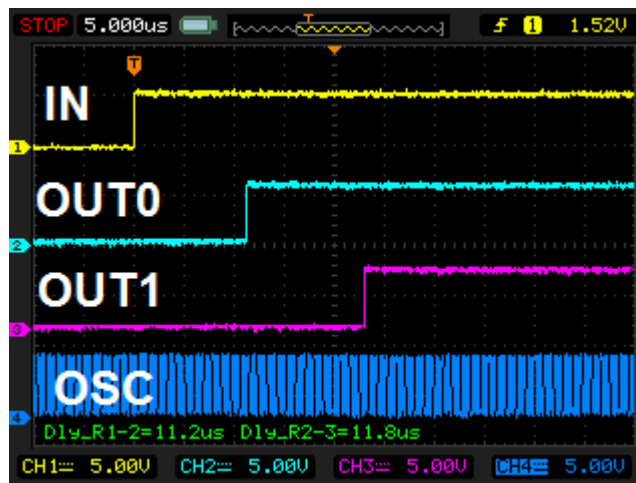
If there are some inner blocks which use RC OSC at the moment or RC OSC is forced power on when such error appears, RC OSC will be operational and delay value will be proper.

- Use the “Force power on” RC OSC power control option to make the RC OSC operate at all times.

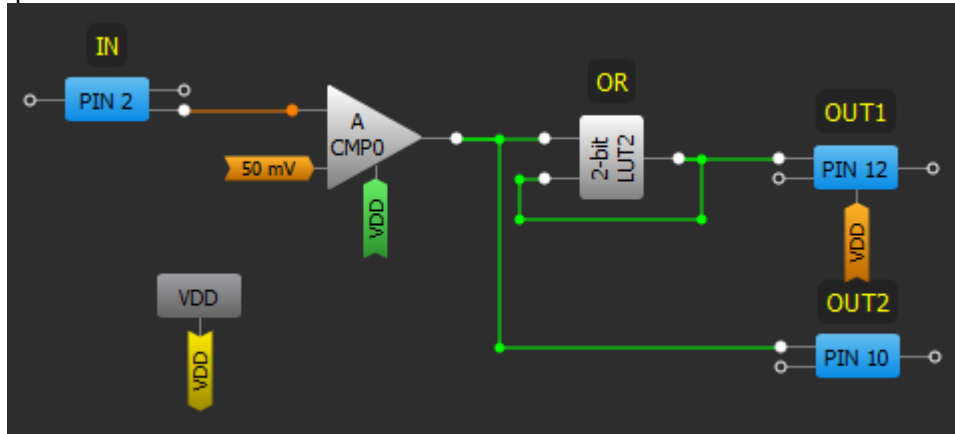
In some cases, ACMP may have short high-level glitches on its output (even if IN+ voltage is less than IN- voltage) after GreenPAK chip being powered up. Such cases may appear when using ACMP with Low Bandwidth mode enabled and Power Up is connected directly to the VDD.

In order to detect such glitches, scheme with additional LUT was used. This LUT detects high level on ACMP output and stays high until chip powers down.

- Use POR block, connected to the ACMP's Power Up pin. However, in this case ACMP will start working with low level output and will be able to go high only after POR goes high + ACMP power on time.

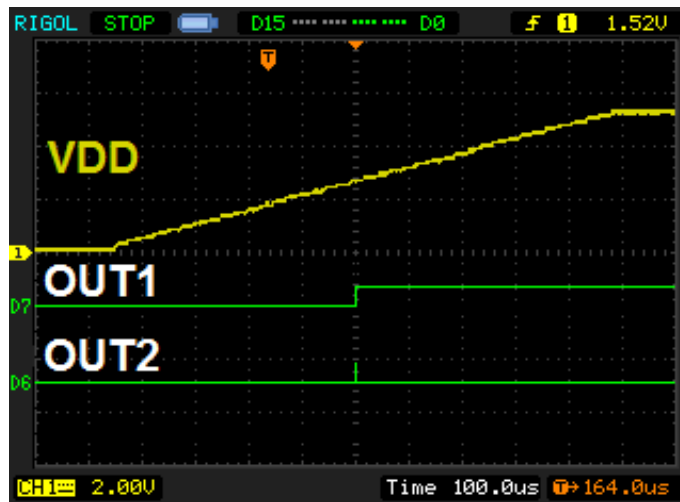
ACMP IN+ is connected to the Ground.

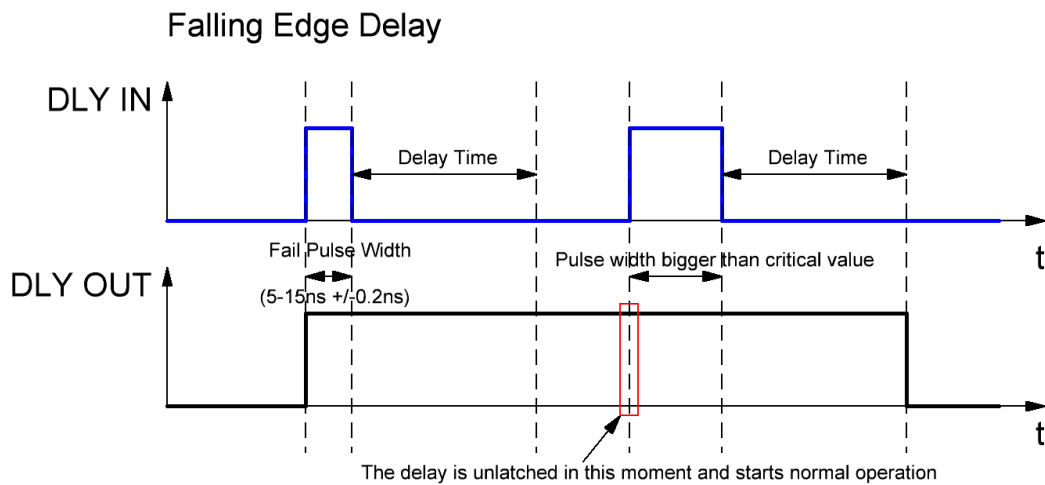
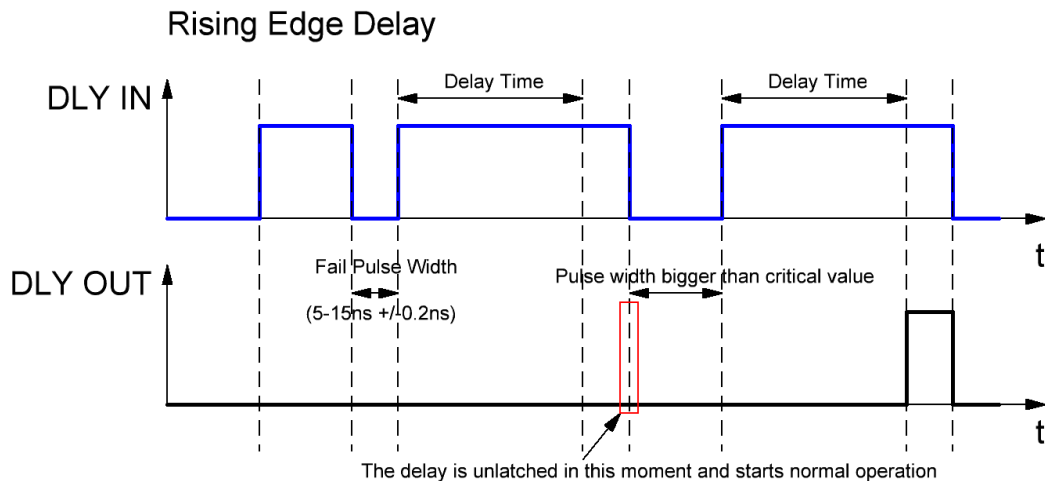
The delay output could be latched despite the input change when a short pulse is input. For example, if the delay cell is configured as a falling edge delay, the short pulse (see NOTE) appears on its input the delay cell output will switch from LOW to HIGH but may not switch from HIGH to LOW even after the delay time has passed.

NOTE: The pulse width varies from chip to chip and with different VDD voltage. It is in range of 5-15ns and in the window  $\pm 0.2\text{ns}$ , so it should be very precise for issue happen.

- Use P DLY/FILTER block configured as a both edge delay or FILTER.

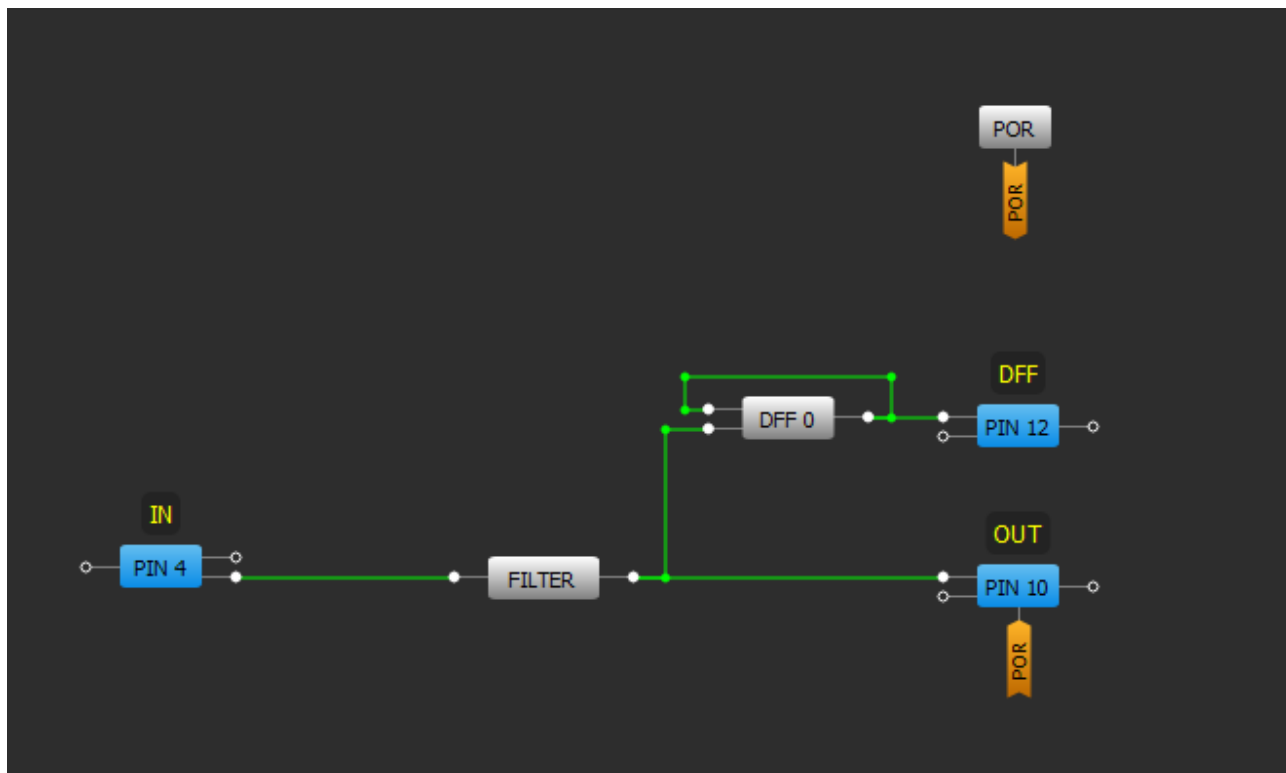
If clock type high frequency input comes in, the FILTER cell may not filter out it. There are several factors like input frequency, duty cycle and LOW duration in such signal that may lead to its passing through FILTER block.

Channel 1 (yellow/top line) – PIN#4 (IN)  
Channel 2 (light blue/2nd line) – PIN#10 (OUT)  
Channel 3 (magenta /3rd line) – PIN#12 (DFF)

Currently there is no workaround for this issue. Filter block is good at filtering short spontaneous glitches. It is intended to be used in series connection before the delay cell to avoid its latching (see issue #5).

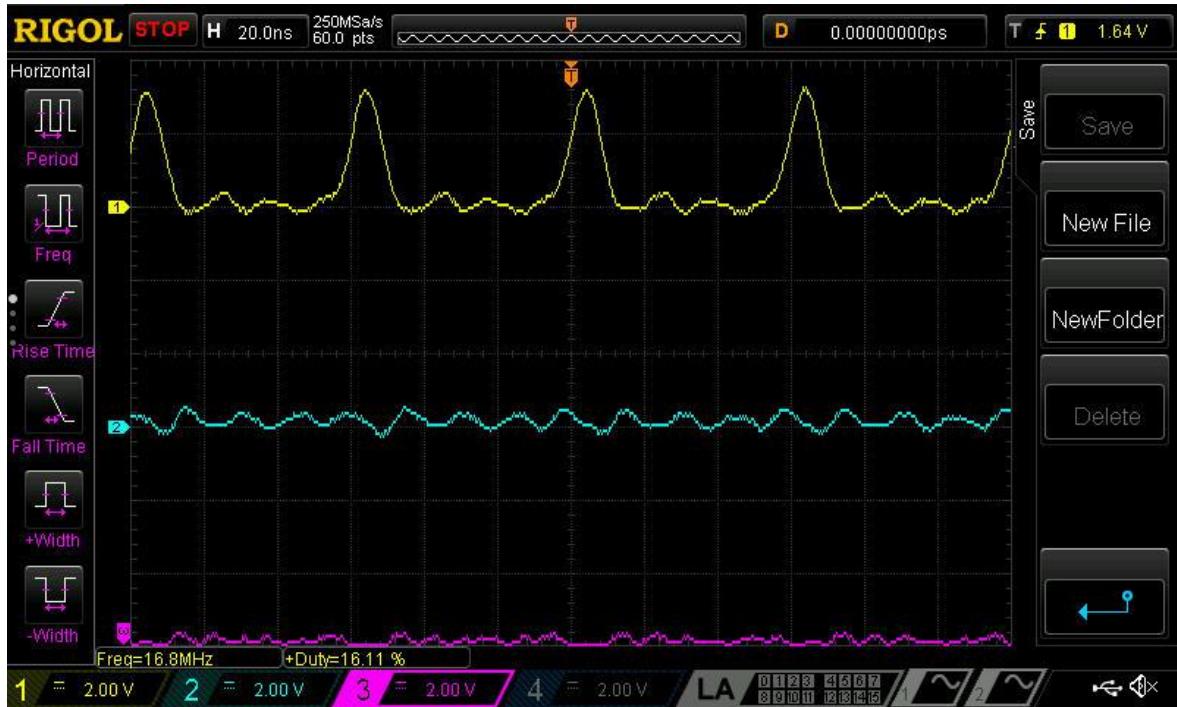
1. Period is 60ns. Pulse width is 10ns DC=16.7% (Correct functionality)

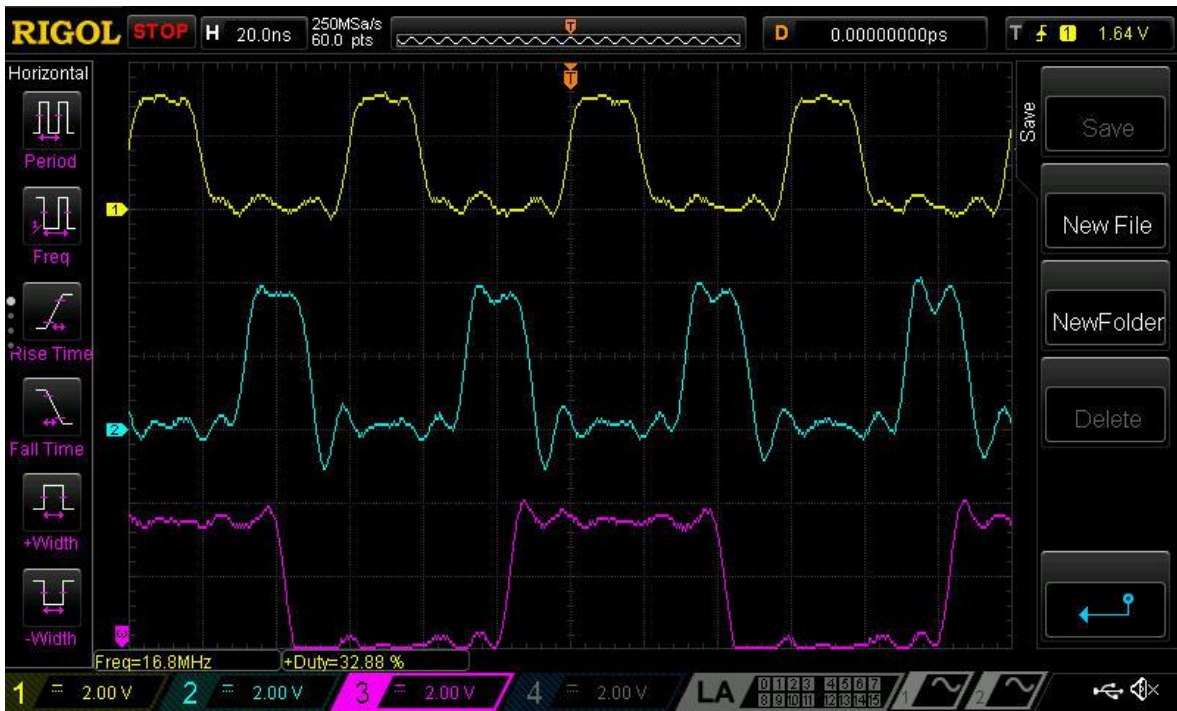
2. Period is 60ns. Pulse width is 20ns DC = 33.3% (Incorrect functionality)

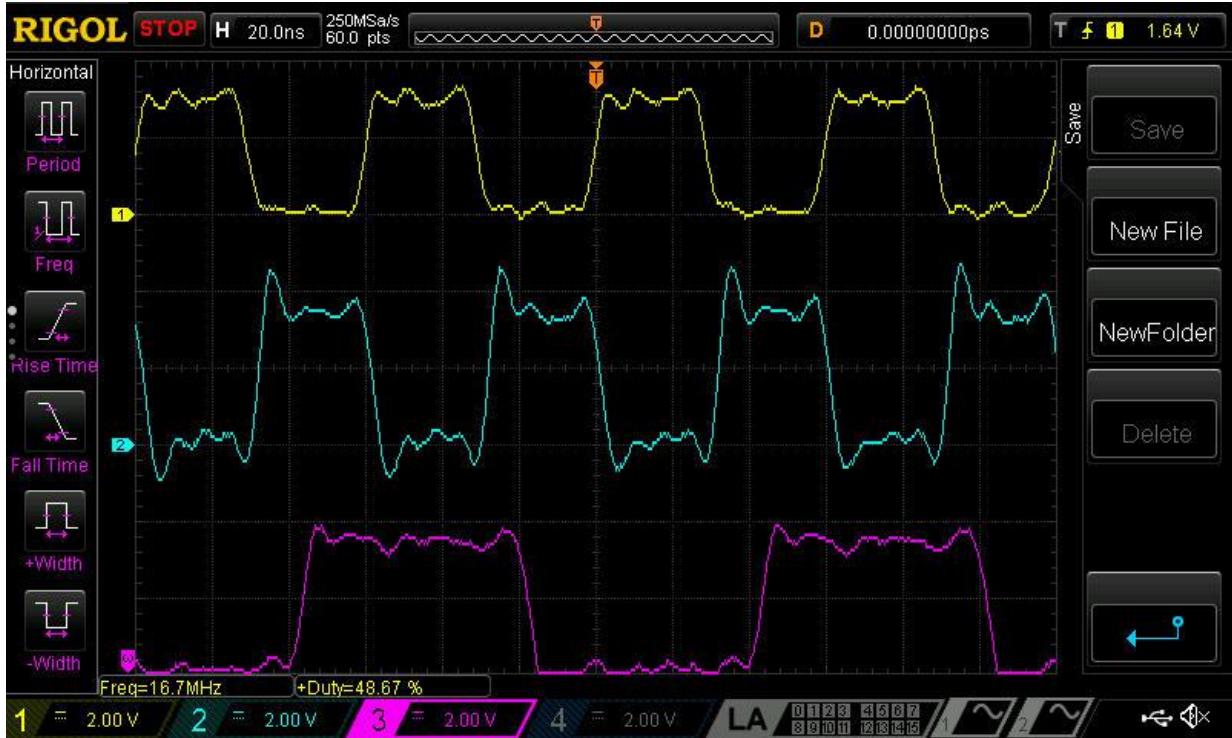
3. Period is 60ns. Pulse width is 30ns DC=50% (Incorrect functionality)

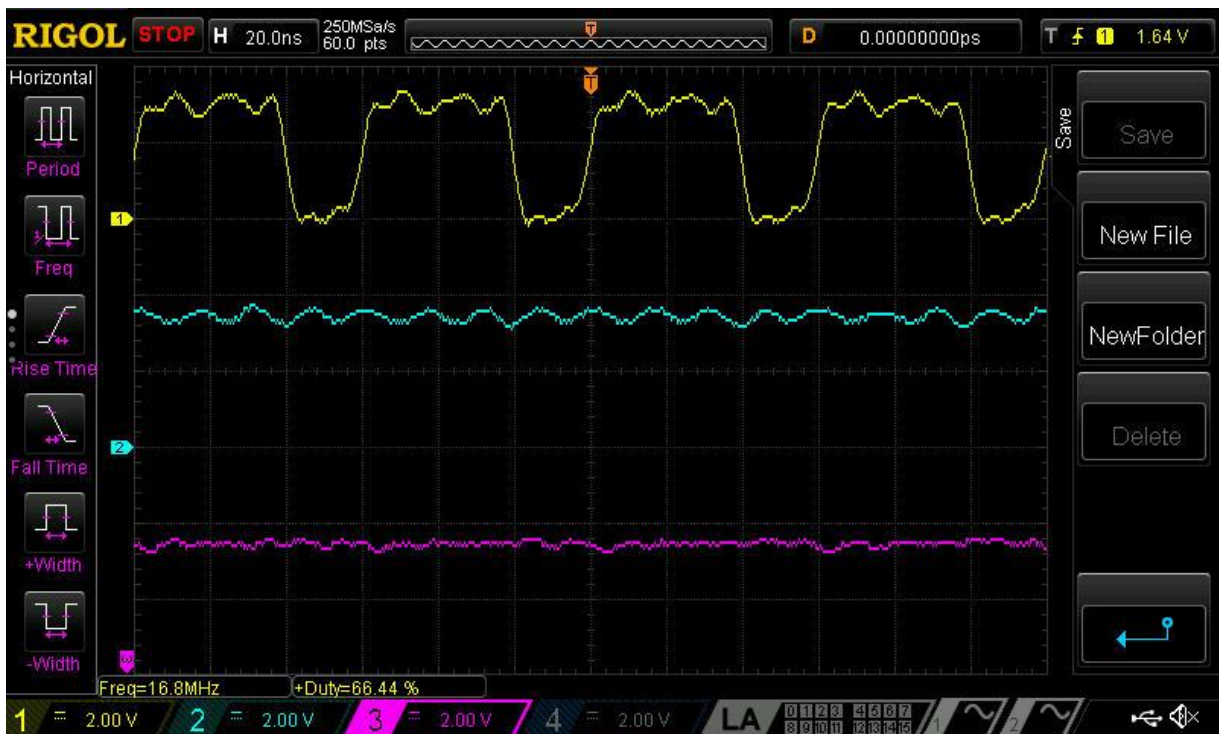
4. Period is 60ns. Pulse width is 40ns DC=66.67% (Correct functionality)
