Errata disclaimer: This Errata applies to SLG46110 revision LT-6G.

ISSUE 1: Long RC OSC Settling Time
Functional Block Affected: RC OSC, Counter, Delay

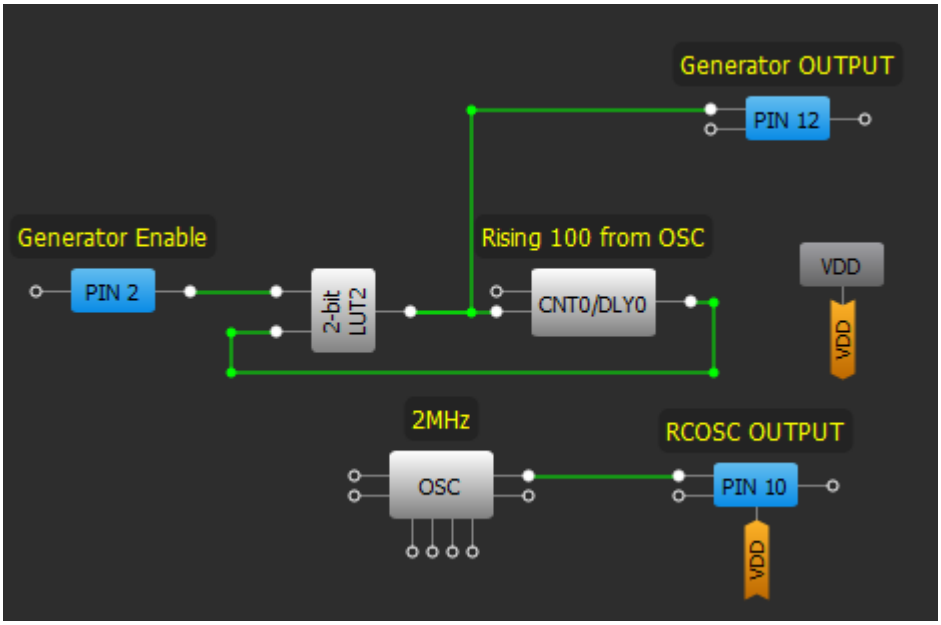
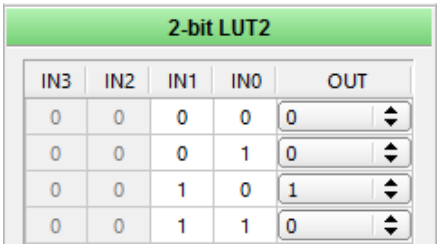
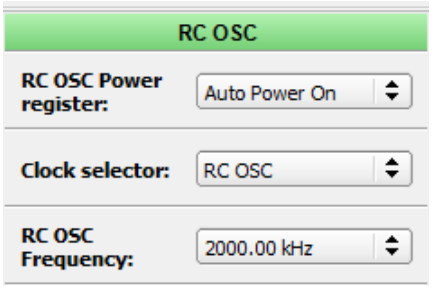
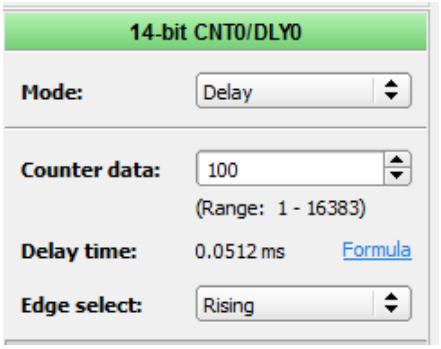
The RC OSC has a longer settling time when configured as 2 MHz with Auto Power On in the designs that have very short RC OSC disable time.

An example of such issue is in the following configuration:

The configuration shown above generates a periodical signal with a frequency defined by the Delay cell and started by a HIGH signal on PIN2. The issue becomes apparent in a longer settling time when the scheme generates short pulses (Delay is configured as a rising edge delay only). See waveform below.

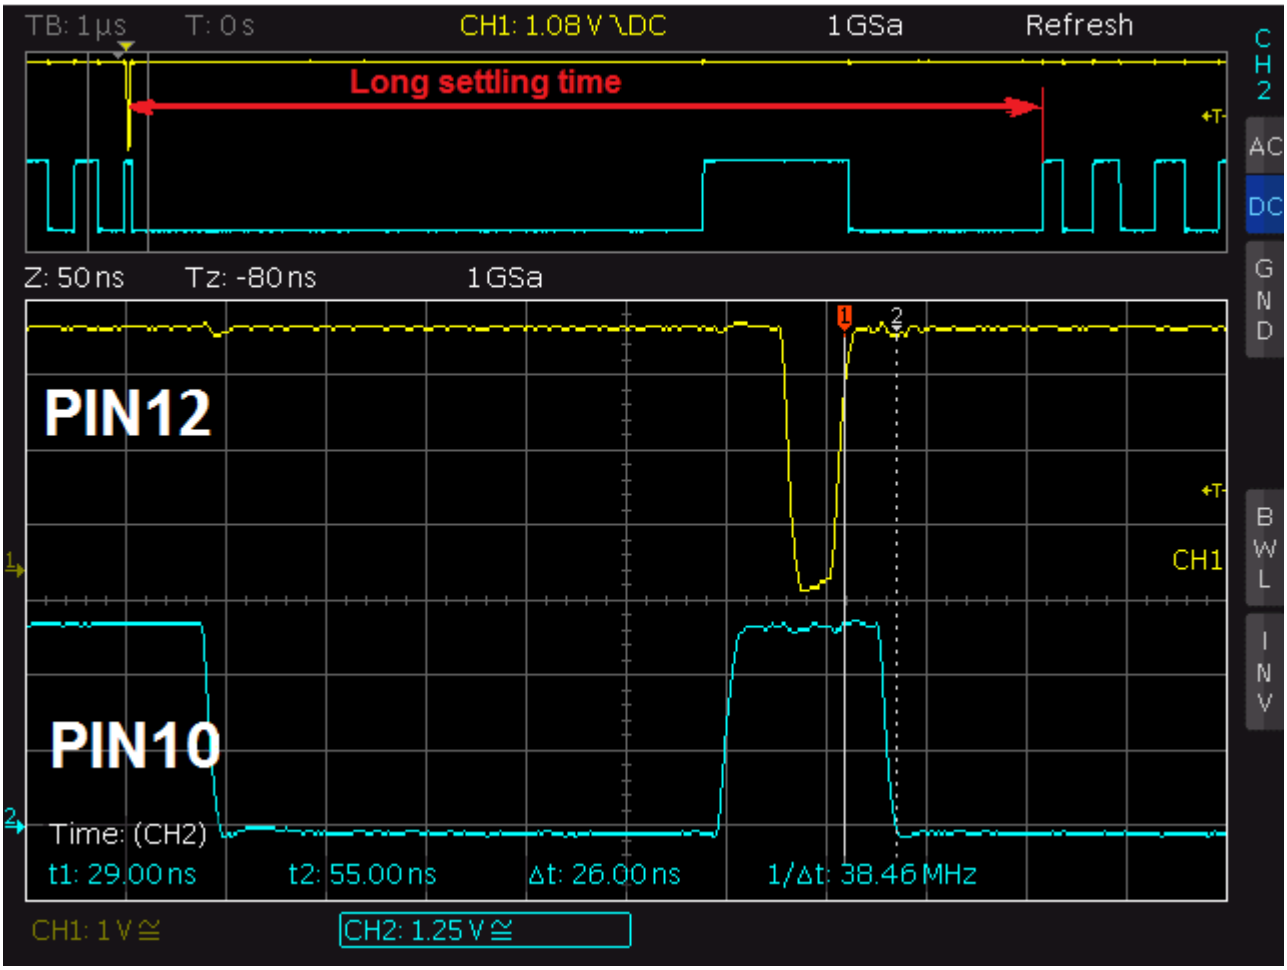
Channel 1 – 2-bit LUT0 output; Channel 2 – RC OSC output

Such behavior will lead to substantial error in period calculations if the delay time is relatively small.

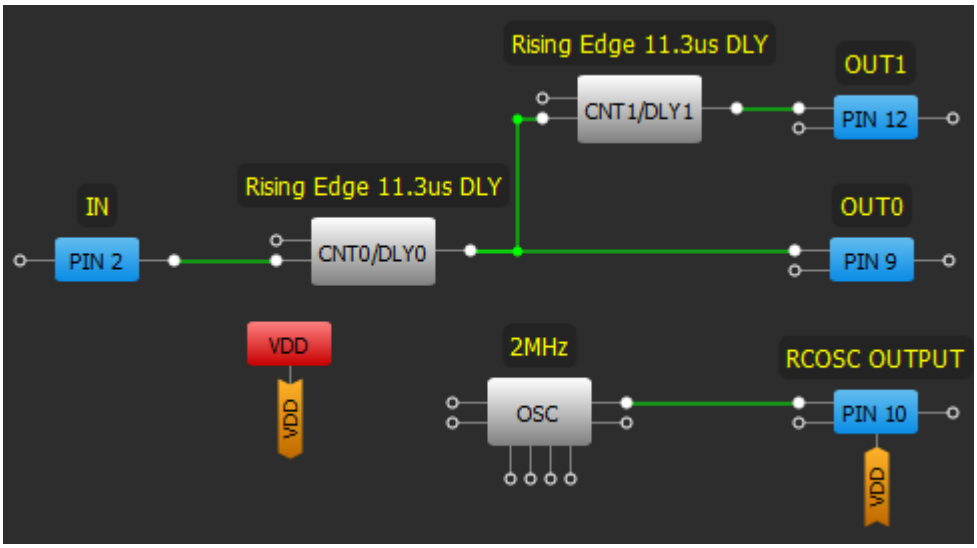
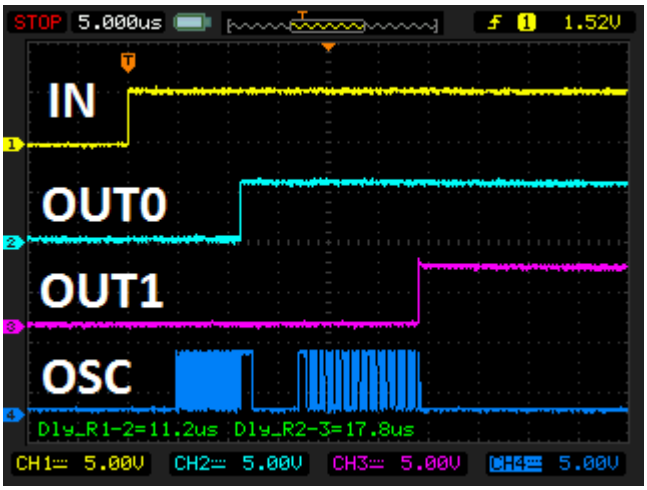
The same situation occur while using two connected delays (all edge detect types except for a pair “Rising edge DLY – Falling edge DLY”).
In the following example, Delay0 and Delay1 are configured in the same way. However, Delay1 time is 17.8us instead of expected 11.3us (Delay0 time).

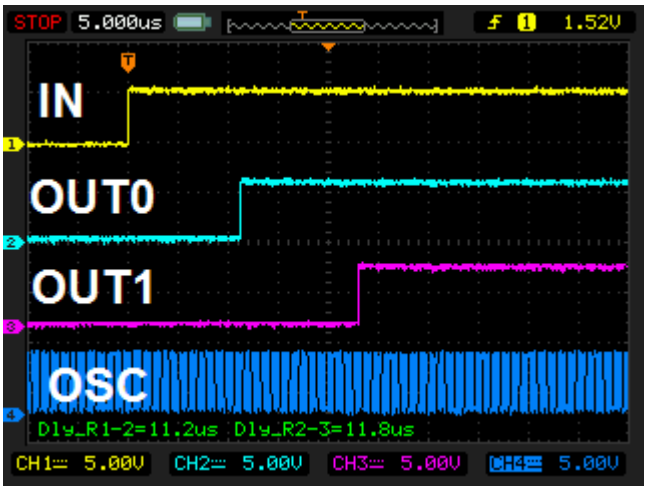
If there are some inner blocks which use RC OSC at the moment or RC OSC is forced power on when such error appears, RC OSC will be operational and delay value will be proper.

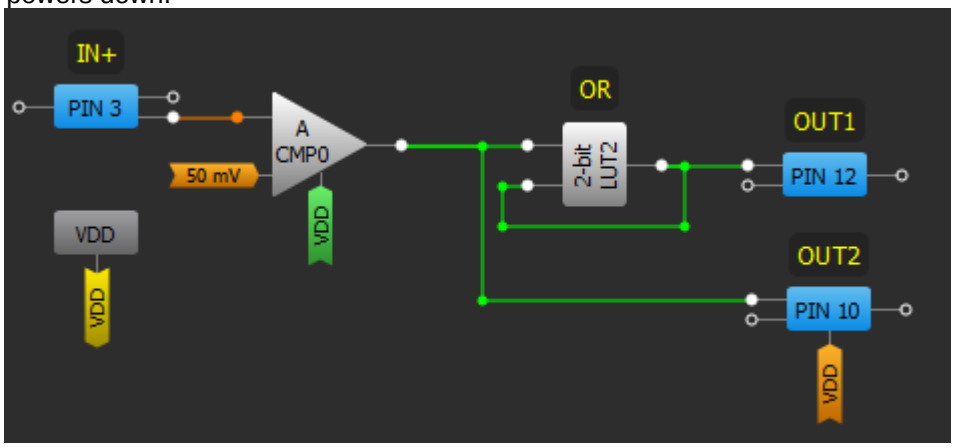
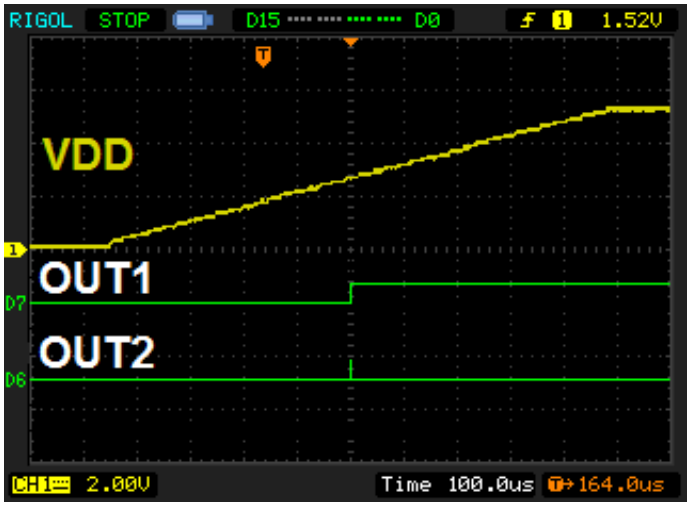
In some cases, ACMP may have short high-level glitches on its output (even if IN+ voltage is less than IN- voltage) after GreenPAK chip being powered up. Such cases may appear when using ACMP with Low Bandwidth mode enabled and Power Up is connected directly to the VDD.

Conditions of glitches appearing are determined by IN- voltage, VDD value and VDD Ramp (see example tables below).

In order to detect such glitches, scheme with additional LUT was used. This LUT detects high level on ACMP output and stays high until chip powers down.

ACMP IN+ is connected to the Ground.

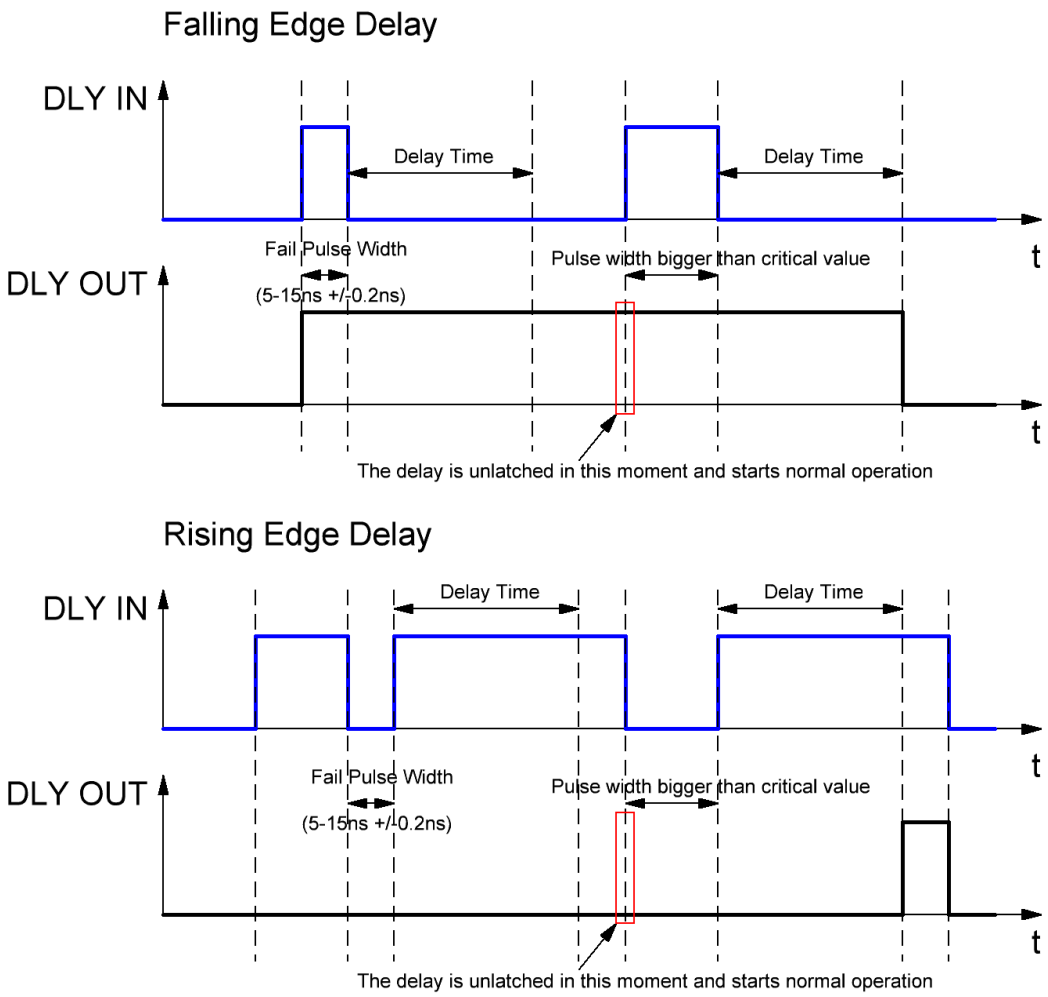
The delay output could be latched despite the input change when a short pulse is input. For example, if the delay cell is configured as a falling edge delay, the short pulse (see NOTE) appears on its input the delay cell output will switch from LOW to HIGH but may not switch from HIGH to LOW even after the delay time has passed.

NOTE: The pulse width varies from chip to chip and with different VDD voltage. It is in range of 5-15ns and in the window +/-0.2ns, so it should be very precise for issue happen.

- Use P DLY/FILTER block configured as a both edge delay or FILTER.
